BUILDING-STRUCTURE INVENTORY FORM DIVISION FOR HISTORIC PRESERVATION NEW YORK STATE PARKS AND RECREATION ALBANY, NEW YORK (518) 474-0479

DATE: June 24, 1992 TELEPHONE: (607)255-6851 YOUR NAME: Tanya M. Velt YOUR ADDRESS: 106 W. Sibley Hall, Ithaca, NY ORGANIZATION (if any): Cornell University

- **IDENTIFICATION** VILLAGE: TOWN/CITY: Corning BUILDING NAME(S): steuben
- 79 East Second Street COUNTY: STREET LOCATION:
- b. private [x] 3.
- ADDRESS: 79 East Second Street OWNERSHIP: a. public[] 5. PRESENT OWNER: Florence Ruocco Residence
- ACCESSIBILITY TO PUBLIC: Exterior visible from public road: Yes[x] 6. USE: Original: Residence Interior accessible: Yes[] No[x] Explain Private residence 7.

Continuation Sheet, Page 1 79 East Second Street Corning, NY

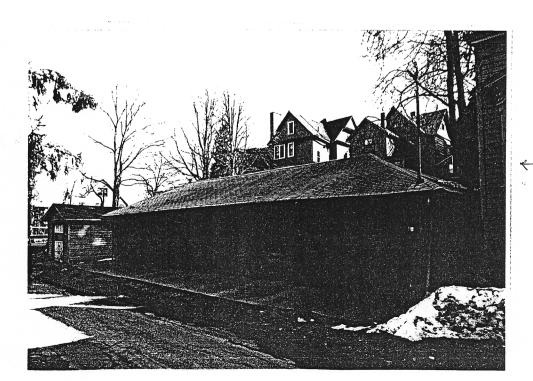
outbuilding

15c. RELATED OUTBUILDINGS--GARAGE: The property includes a ca. 1913 - 1921 six-car, rectangular garage. The garage faces north onto the alley between East First and East Second streets. A hipped roof with asphalt shingles protects the molded concrete block structure.
