BUILDING-STRUCTURE INVENTORY FORM

- 1. BUILDING NAME(S):
- 2. COUNTY: Steuben TOWN/CITY: Coming VILLAGE:
- 3. STREET LOCATION: 130 Cedar Street
- 4. OWNERSHIP: a. public [] b. private [X]
- 5. PRESENT OWNER: Vincent J. Welch ADDRESS: 17-19 East Market Street, Coming, NY 14830
- 6. USE: Original: Residential Present: Residential
- 7. ACCESSIBILITY TO PUBLIC: Exterior visible from public road: Yes [X] No []
Interior accessible: Yes [] No [X] Explain: Private Residence

CONTINUATION SHEET, page 1
130 Cedar Street
Corning, New York

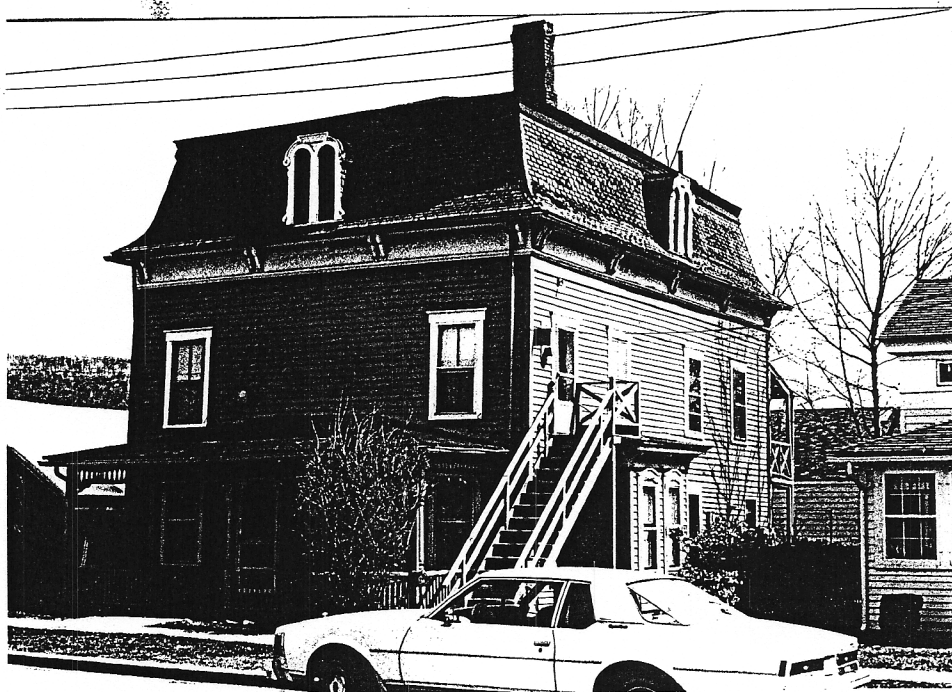
130 Cedar St ↗

This two-and-a-half-story house has a rectangular mass, the shorter side facing the street. The structure is topped by a mansard roof that is defined in A Fields Guide To American Houses (V. & L. McAlester, 1984) as "straight with a flare." Other notable features of the two-family residence include an Eastlake porch across the western (front) facade, a projecting window bay on the south facade, paired brackets on the molded cornice, and centrally placed dormer windows on the north, south, and west facades. These dormers feature two round arch windows in an elaborate scrolled frame. The eastern facade has a two-story porch with an enclosed outdoor stairway that appears to be of recent construction. The placement of doors and window on the western facade does not match the symmetrical arrangement associated with the style. These features may have been altered over time or during the conversion of the previously single-family residence into apartments. The building is covered in wooden clapboarding.
