BUILDING-STRUCTURE INVENTORY FORM

- 1. BUILDING NAME(S):
- 2. COUNTY: Steuben TOWN/CITY: Corning VILLAGE:
- 3. STREET LOCATION: 213 Cedar Street
- 4. OWNERSHIP: a. public [] b. private [X]
- 5. PRESENT OWNER: Theodore K. and Carol Ann Imhoff ADDRESS:
Present: Residence
- 6. USE: Original: Residence
- 7. ACCESSIBILITY TO PUBLIC: Exterior visible from public road: Yes [X] No []
Interior accessible: Yes [] No [X] Explain: Private residence

CONTINUATION SHEET, Page 1
213 Cedar Street
Corning, New York

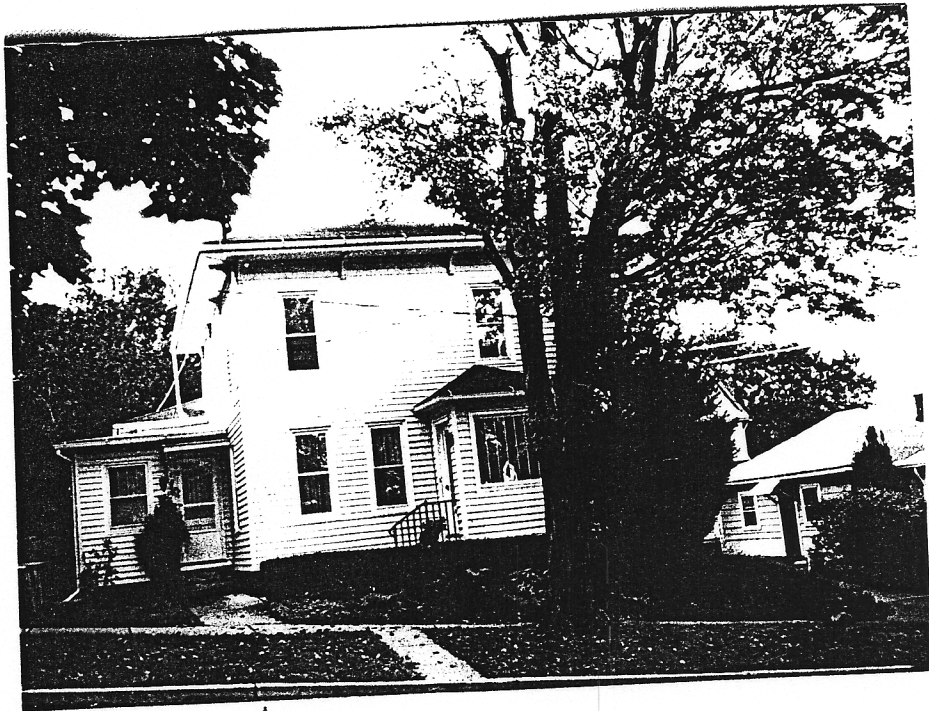
↑ 213 Cedar

This house is an example of the Italianate style of architecture. It has a hipped roof on both the two story main mass of the house and the one-story rear section. The roof has overhanging eaves with "supported" by decorative brackets. The house rests on a fieldstone foundation (the foundation on the rear (east) section of the house is parged) with basement level windows.

The front (east) facade has two entrances. The first is in the one story enclosed porch on the south facade. The door faces east and has a one-over-one-light double-hung window to the immediate south of it. The second entrance is in the third bay of the main mass of the house, and faces south. This entrance is actually an entry porch with a hipped roof and wrought iron balustrade. The east facade of the entry porch has a large square window with long rectangular lights. The first level of this facade also contains two one-over-one-light double-hung windows in the first two bays. The second level features two of the same in the first and third bays only. There is no window in the second bay area.

The north facade features one awning window and two one-over-one-light double-hung sash. The second level features two one-over-one-light double-hung windows. There is also a door on facing north on the rear section of the house. The west facade also features a hipped roof shelter supported by three square piers. There is one visible brick chimney. An outbuilding with a hipped roof and clad in stucco lies to the west of the house and features car doors on the north facade and an entry door and six-light window on the east facade.
