CONTINUATION SHEET, Page 1  
236 Cedar Street  
Corning, New York

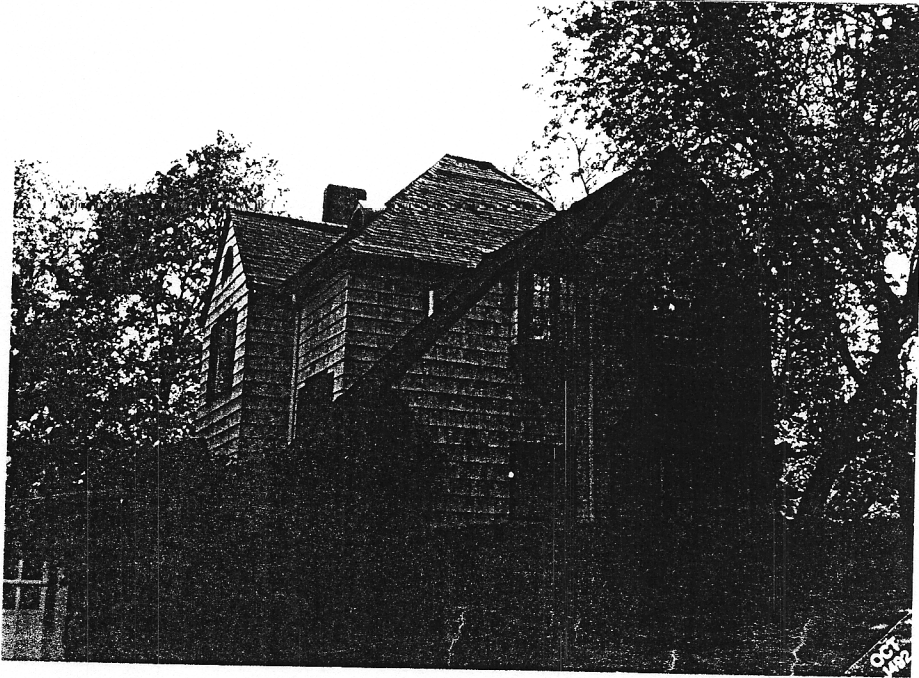
← 236  
Cedar

This residence is of the Tudor Style (McAlester, A Field Guide to American Houses) with multiple front gables and an oriel window. However, it is entirely clad in wooden shingles, which is not a feature common to this style. The central hipped roof and multiple intersecting gable roofs have an asphalt covering. There are several Tudor Style houses in the Southside neighborhood, and this building is fairly similar to one located across the street at 239 Cedar.

The structure is two-and-a-half-stories high and includes a cutaway porch at the lowest, north end of the front-facing main gable. The front, west facade also includes an oriel window on the second floor level and a one-story bay window on the first floor level.
