**BUILDING-STRUCTURE INVENTORY FORM**

- 1. BUILDING NAME(S):
- 2. COUNTY: Steuben TOWN/CITY: Corning VILLAGE:
- 3. STREET LOCATION: *101 West Fifth Street*
- 4. OWNERSHIP: a: public [ ] b: private [ X ]
- 5. PRESENT OWNER: *John Stephen & Ahlene Salley* ADDRESS: *101 West Fifth Street*
- 6. USE: Original : *Single-family residence* Present: *Single-family residence*
- 7. ACCESSIBILITY TO PUBLIC: Exterior visible from public road: Yes [ X ] No [ ]  
Interior accessible: Yes [ ] No [ X ] Explain: *Private residence*

CONTINUATION SHEET, Page 1  
101 West 5th Street  
Corning, New York

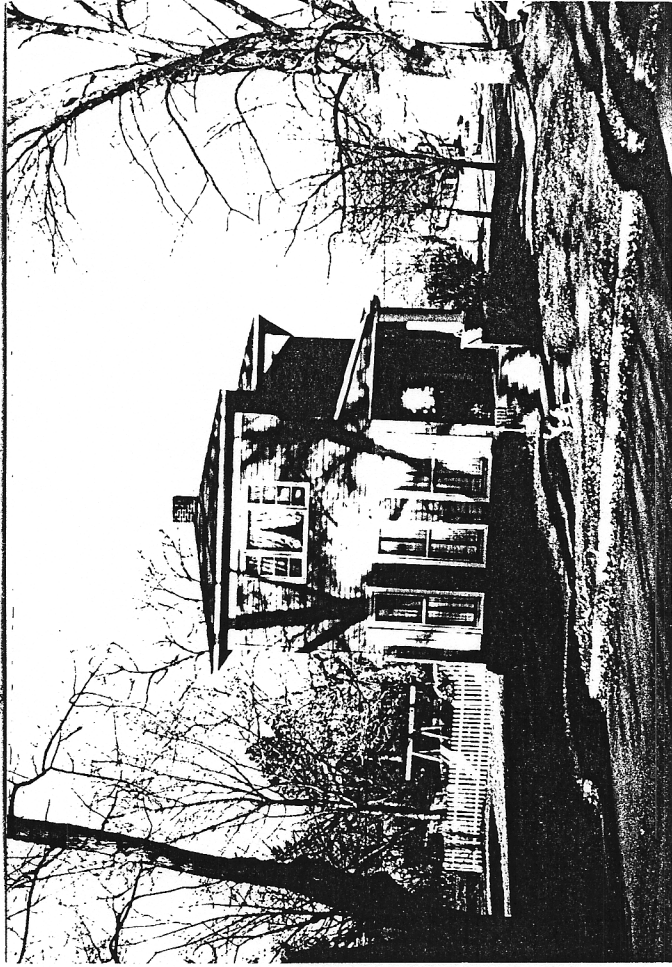
Northeast Facade

Although it has been greatly modified, this residence is an example of the Italianate Style. Among the remaining features of the style which can be seen in the architecture of home are the wide overhanging eaves, the box-like massing of the building, and the low-pitched hipped roof. The main entrance is located on the front (south) facade. Most of the windows are one-over-one double-hung sash. A three-part picture window has been installed on the south facade of the second story. A one-story bay window is attached to the east facade. To the left of this window, the east facade is partially obscured by a porch which has a closed railing with three tuscan columns to support the porch roof.

A one-story wing is attached to the north (rear) facade. The residence is sided in clapboard, and the hipped roof is done in asphalt shingles. The foundation is constructed of stone and is covered with stucco. A brick chimney is centered atop the roof.
