BUILDING-STRUCTURE INVENTORY FORM

- 1. BUILDING NAME(S):
- 2. COUNTY: Steuben TOWN/CITY: Corning VILLAGE:
- 3. STREET LOCATION: *110 West Fifth Street*
- 4. OWNERSHIP: a: public [] b: private [X]
- 5. PRESENT OWNER: *Kevin & Margaret Roe* ADDRESS: *110 West Fifth Street*
- 6. USE: Original : *Single-family residence* Present: *Single-family residence*
- 7. ACCESSIBILITY TO PUBLIC: Exterior visible from public road: Yes [X] No []
Interior accessible: Yes [] No [X] Explain: *Private residence*

CONTINUATION SHEET, Page 1
110 West 5th Street
Corning, New York

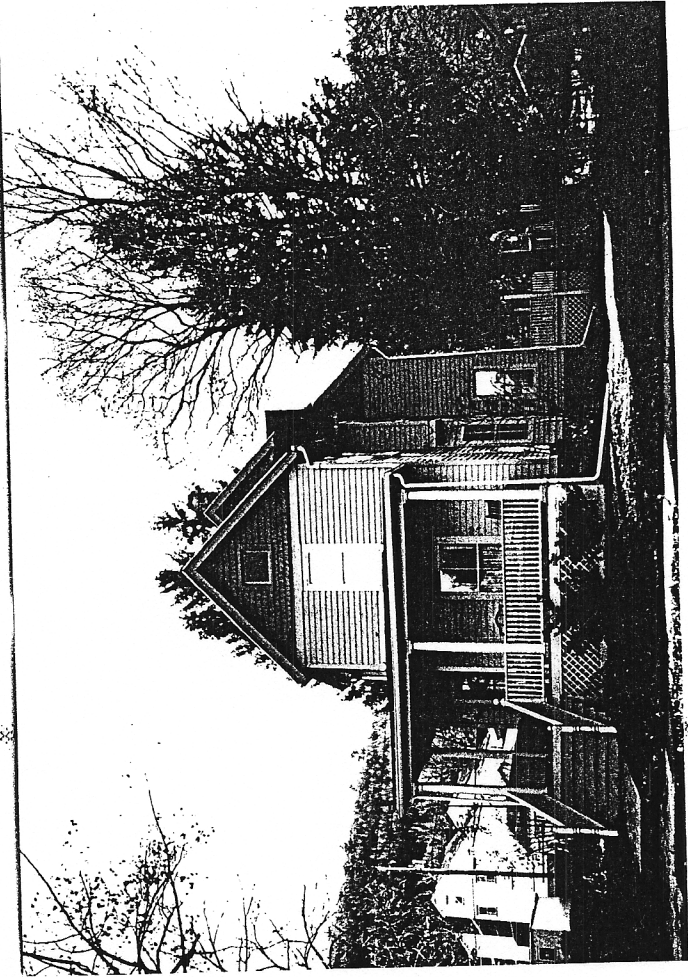
Northeast Facade

The central gabled section of this residence projects out toward Fifth Street. A wraparound porch is attached at the northeast corner; it has an open railing and Doric columns. The fenestration is symmetrical and the windows are primarily one-over-one double-hung sash. A square window is centered in the gable end. The main entrance faces north. A brick chimney is placed atop the roof.

The house is sided in wood clapboards with decorative shingles in the gable end. The foundation wall is prominent and is made of stone.
