19. DATE OF INITIAL CONSTRUCTION: ca. 1890

CONTINUATION SHEET, Page 1
133 West 5th Street
Corning, New York

11C. MAJOR ALTERATIONS AND DATES:

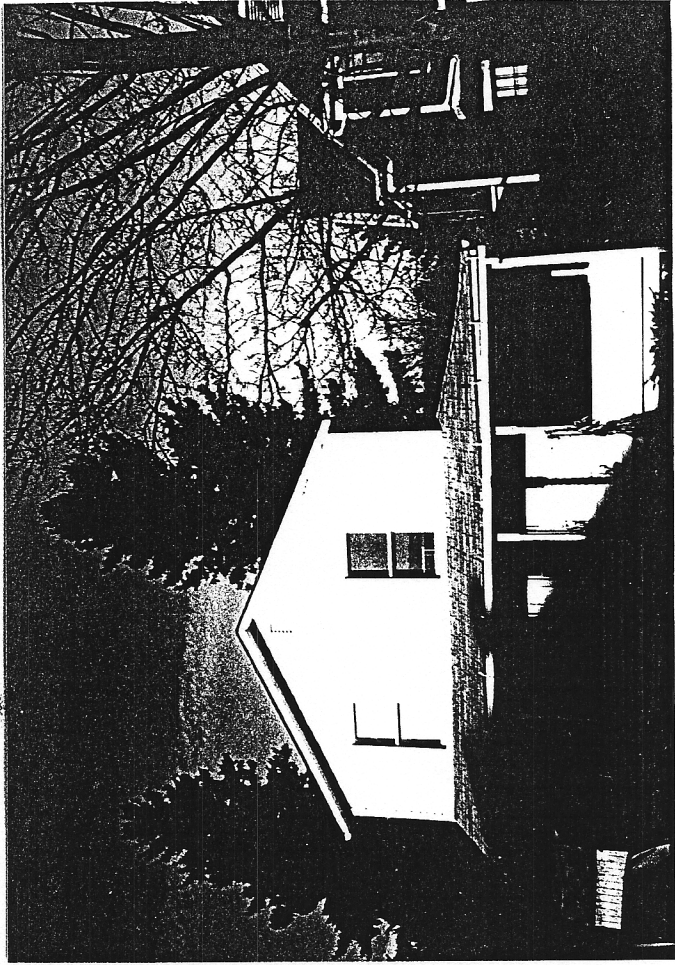
Southwest Facade

An example of an open-gable cottage, according to Herbert Gottfried & Jan Jennings in their book American Vernacular Design. Open-gable cottage houses are notable for their basic form from a single feature or a few design elements. In referring this cottage as an open-gable, it refers to its wide gable and its plain form. "It could just be called the flush-wall, center axis cottage, because these features characterize its design." A wraparound porch surrounds the south and east facades. It has closed railing and turned posts.

The gabled section of this residence projects out toward Fifth Street. The fenestration is symmetrical and the windows are primarily one-over-one double-hung sash. The house is sided in vinyl. The roof is made of asphalt shingles and a brick chimney is centered atop the roof. The foundation is made of brick and covered with stucco.
