BUILDING-STRUCTURE INVENTORY FORM

- 1. BUILDING NAME(S):
- 2. COUNTY: Steuben TOWN/CITY: Corning VILLAGE:
- 3. STREET LOCATION: 19 West Fifth Street
- 4. OWNERSHIP: a. public [] b. private [x]
- 5. PRESENT OWNER: Robert J. and Margaret Kane ADDRESS: Same
- 6. USE: Original: single-family residence Present: single-family residence
- 7. ACCESSIBILITY TO PUBLIC: Exterior visible from public road Yes[x] No []
Interior accessible: Yes [] No [x]

19. DATE OF INITIAL CONSTRUCTION: 1892

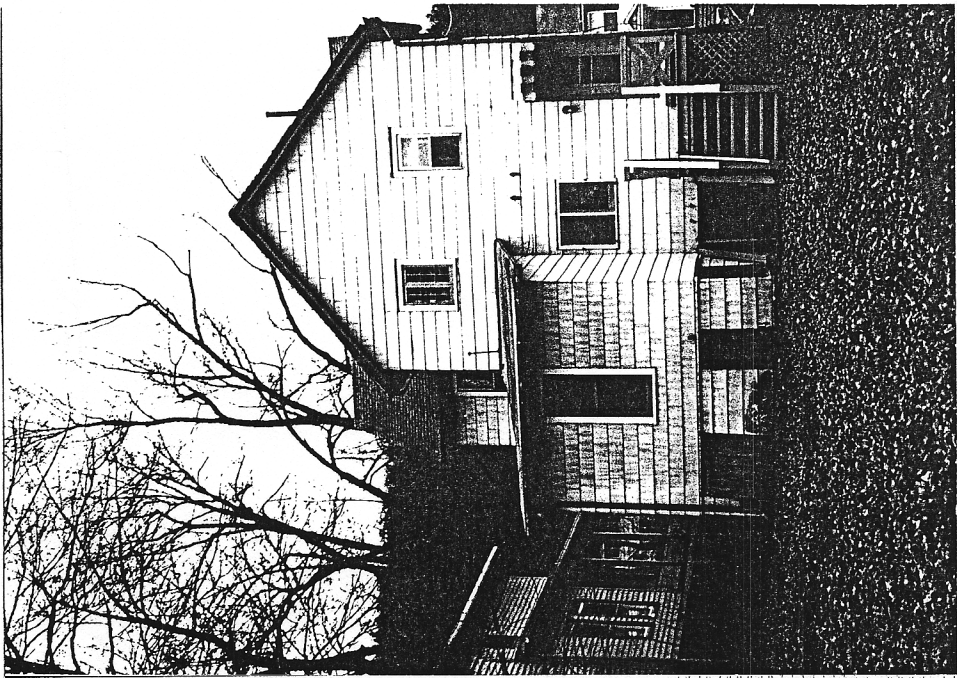
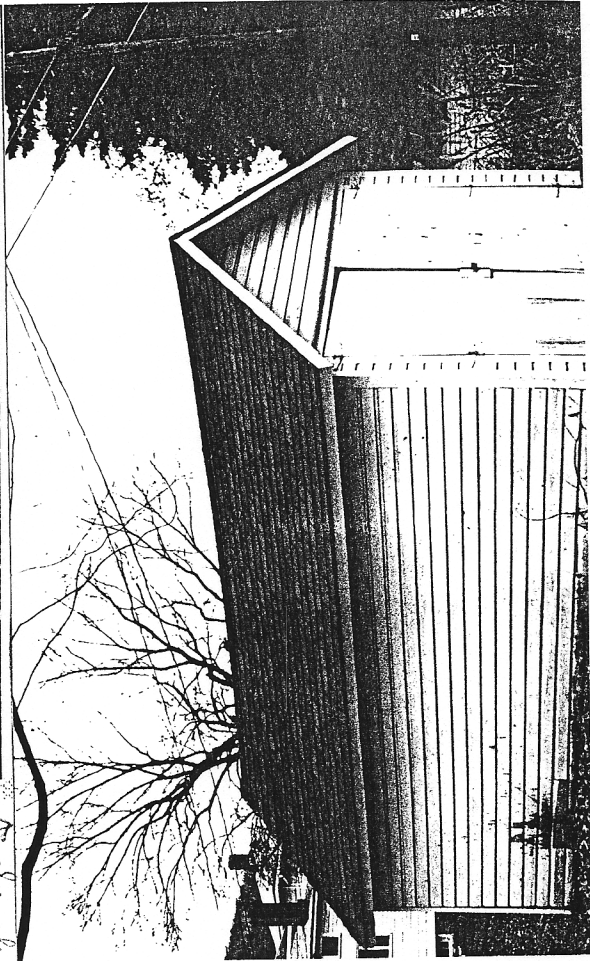
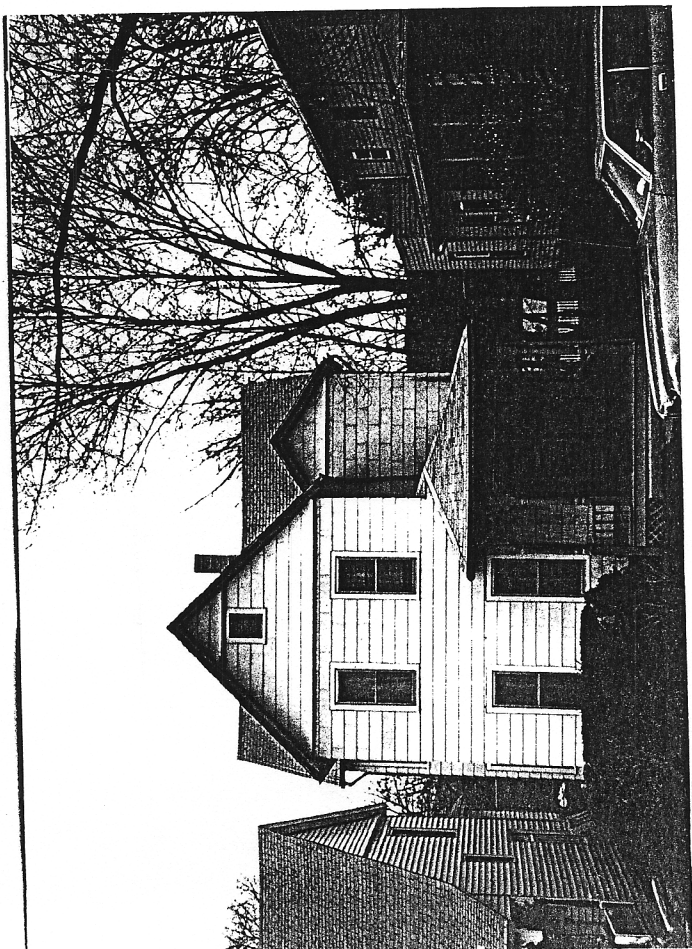
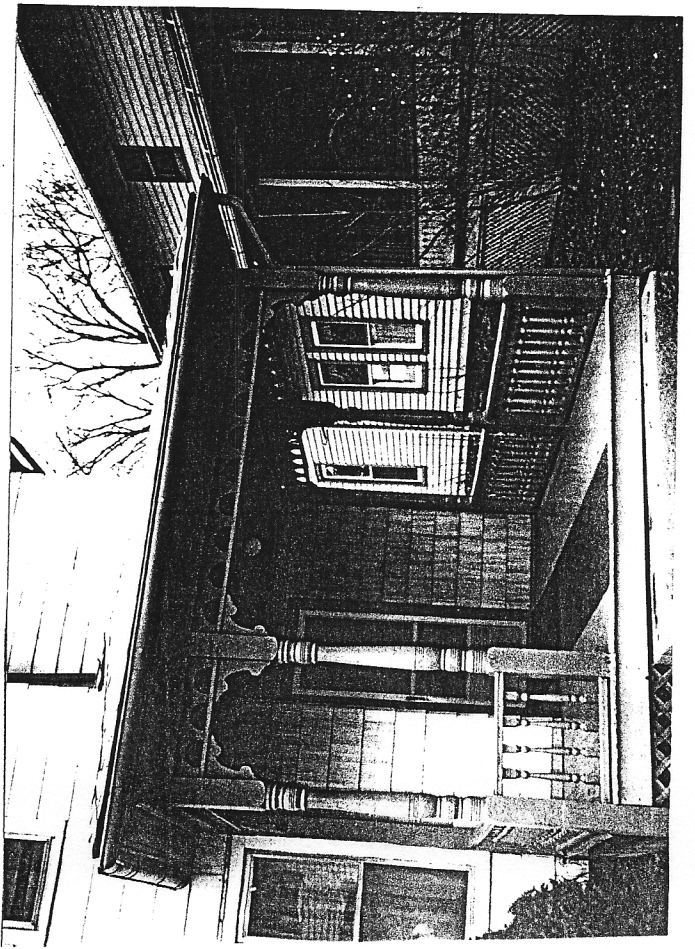
all 19 West 5th

This two-story, detached residence is typical of the gabled-ell-style of worker housing. The front gable faces south and features two bays punctuated by evenly spaced one-over-one windows. The one-story, covered entrance porch on the eastern edge of the main facade features a hipped roof, turned wood spindles, a carved frieze, and decorative brackets. The house is set on parged fieldstone and covered in asbestos shingles. The steeply-pitched gabled roof is covered in asphalt shingles. There is an interior cinder block chimney.

The one-story garage at the rear of the lot is a simple rectangular building. Its longitudinal axis runs north to south. The double doors open out to the north. The outbuilding is covered in simple-bevel, horizontal, wood clapboards. The roof is covered with asphalt shingles.
