BUILDING-STRUCTURE INVENTORY FORM

- 1. BUILDING NAME(S): The Mary Leavy House
- 2. COUNTY: Steuben TOWN/CITY: Corning VILLAGE:
- 3. STREET LOCATION: 22 West Fifth Street
- 4. OWNERSHIP: a. public [] b. private [x]
- 5. PRESENT OWNER: Ellen M. Riley and Barry Perryman ADDRESS: 22 W. Fifth Street
- 6. USE: Original: single-family residence Present: single-family residence
- 7. ACCESSIBILITY TO PUBLIC: Exterior visible from public road Yes[x] No []
Interior accessible: Yes [] No [x] Explain: Private Residence

19. DATE OF INITIAL CONSTRUCTION: ca. 1926

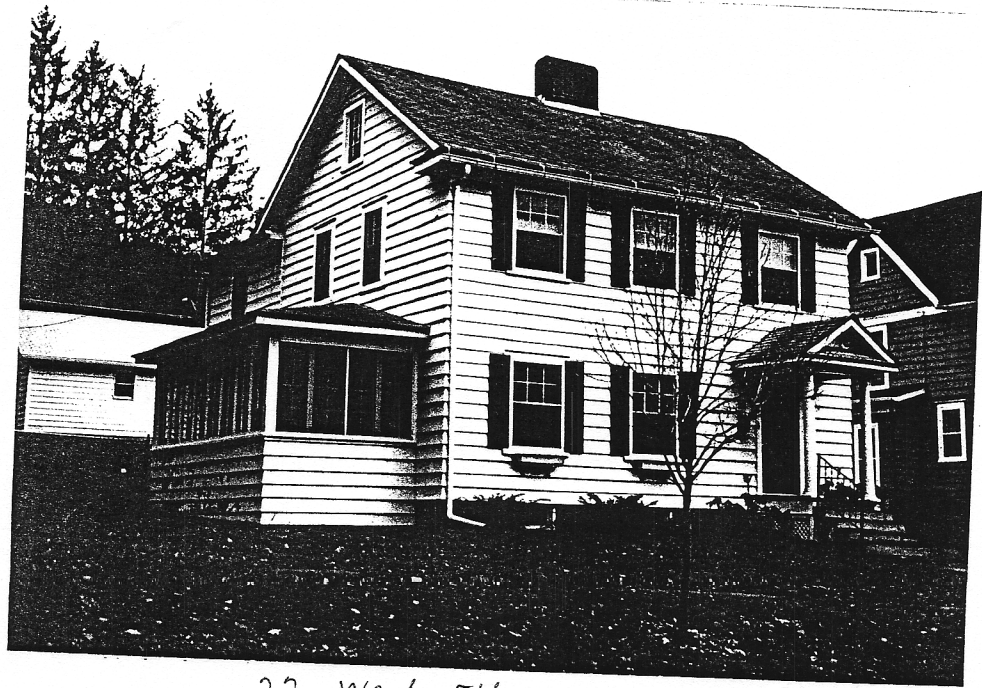
22 West 5th

This two-story house is designed in the Colonial Revival Style of architecture. The house is side-gabled with a three-bay front. On the east and west facades, the eaves return. The windows are six-over-one light sash and the inoperable shutters on the front windows may be original. The exterior wall material is clapboard siding. The main entrance, which is in the westernmost bay of the north facade, is accessed via a one-story pedimented portico supported by Doric columns. On the east facade there is an original one-story enclosed entry porch with a hipped roof. The porch is covered at its base with clapboard and has casement windows on all sides.

The house is set on a partially raised basement. The foundation has been parged, but judging from the style and date of the building, it is probably cast stone or concrete block.
