BUILDING-STRUCTURE INVENTORY FORM
DIVISION FOR HISTORIC PRESERVATION
NEW YORK STATE PARKS AND RECREATION
ALBANY, NEW YORK (518) 474-0479

1. BUILDING NAME(S): The Emily E. Dow House
2. COUNTY: Steuben TOWN/CITY: Corning VILLAGE:
3. STREET LOCATION: 40 West Fifth Street
4. OWNERSHIP: a. public [] b. private [x]
5. PRESENT OWNER: Jeanne M. Spadinger ADDRESS: 40 West Fifth Street
6. USE: Original: single-family residence Present: single-family residence
7. ACCESSIBILITY TO PUBLIC: Exterior visible from public road Yes[x] No []
Interior accessible: Yes [] No [x] Explain: Private Residence

40 West Fifth Street

Corning, NY

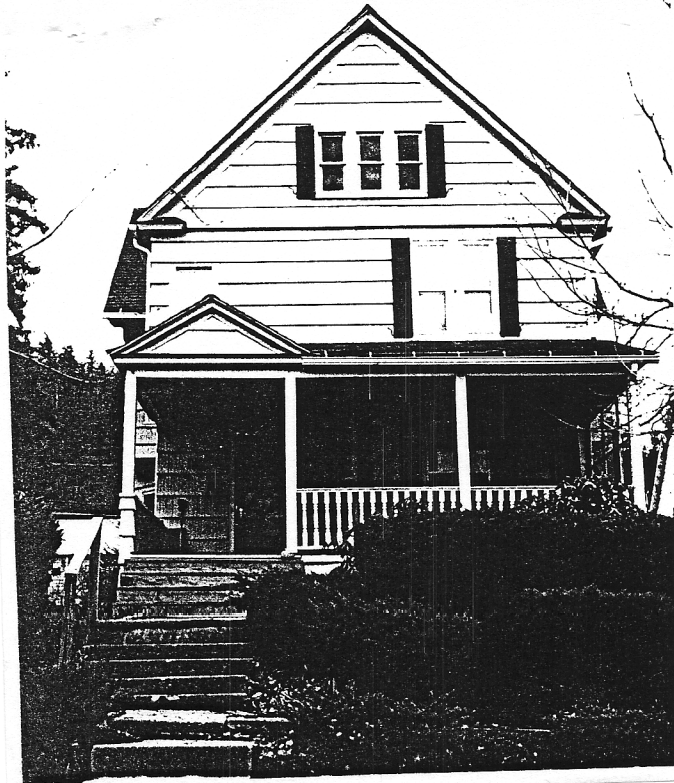
40 West 54th

This cross-gabled two-and-a-half story house is of the late Queen Anne Style. The gable ends return slightly at the front gable and there is a cut-away bay at the northwest corner of the house. Additionally, there is a sawn bracket support at this bay. The windows are one-over-one sash and there is a chimney at the interior ridge.

There are two similar porches--one at the north and one at the southeast corner of the house. Both are one story with square support posts and shed roofs. The southern, or front porch, has turned posts and the entry is accented with a pedimented gable. The balusters of the rear, or southeast porch, have been enclosed with shingles.
