BUILDING-STRUCTURE INVENTORY FORM

- 1. BUILDING NAME(S):
- 2. COUNTY: Steuben TOWN/CITY: Corning VILLAGE:
- 3. STREET LOCATION: 64 West Fifth Street
- 4. OWNERSHIP: a. public b. private
- 5. PRESENT OWNER: Matthew A. & Donna G. Zirkle ADDRESS: 64 West Fifth Street
- 6. USE: Original: single-family residence Present: single-family residence
- 7. ACCESSIBILITY TO PUBLIC: Exterior visible from public road Yes No
Interior accessible: Yes No Explain: Private Residence

CONTINUATION SHEET, Page 1
64 West Fifth Street
Corning, NY

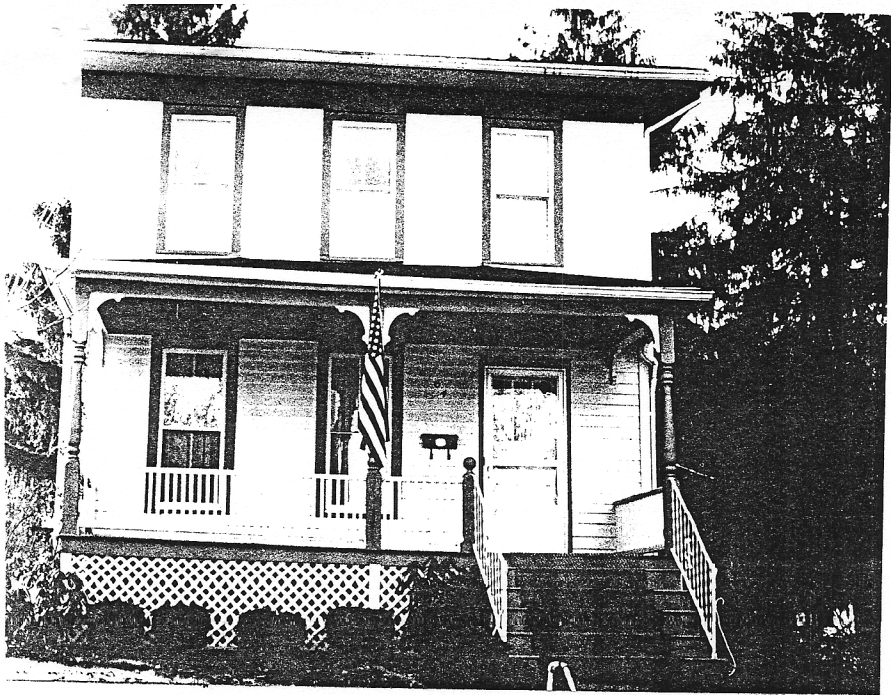
64 West
5th

This two-story structure with a rectangular-shaped plan is built in the Italianate Style of architecture. A single-story wing forms the southeast corner. It has a low-pitch hipped roof and a three-ranked front (north) facade, with the entrance in the center. A full-width single-story porch spans the front facade. An enclosed porch is attached to the rear (south) of the house.
