BUILDING-STRUCTURE INVENTORY FORM

- 1. BUILDING NAME(S):
- 2. COUNTY: Steuben TOWN/CITY: Corning VILLAGE:
- 3. STREET LOCATION: 98 West Fifth Street
- 4. OWNERSHIP: a. public[] b. private[X]
- 5. PRESENT OWNER: Mary Kathryn Brooder ADDRESS: 98 West Fifth Street
- 6. USE: Original: single-family residence Present: single-family residence
- 7. ACCESSIBILITY TO PUBLIC: Exterior visible from public road Yes[X] No []
Interior accessible: Yes [] No [X] Explain: Private Residence

CONTINUATION SHEET, Page 2
98 West Fifth Street
Corning, NY

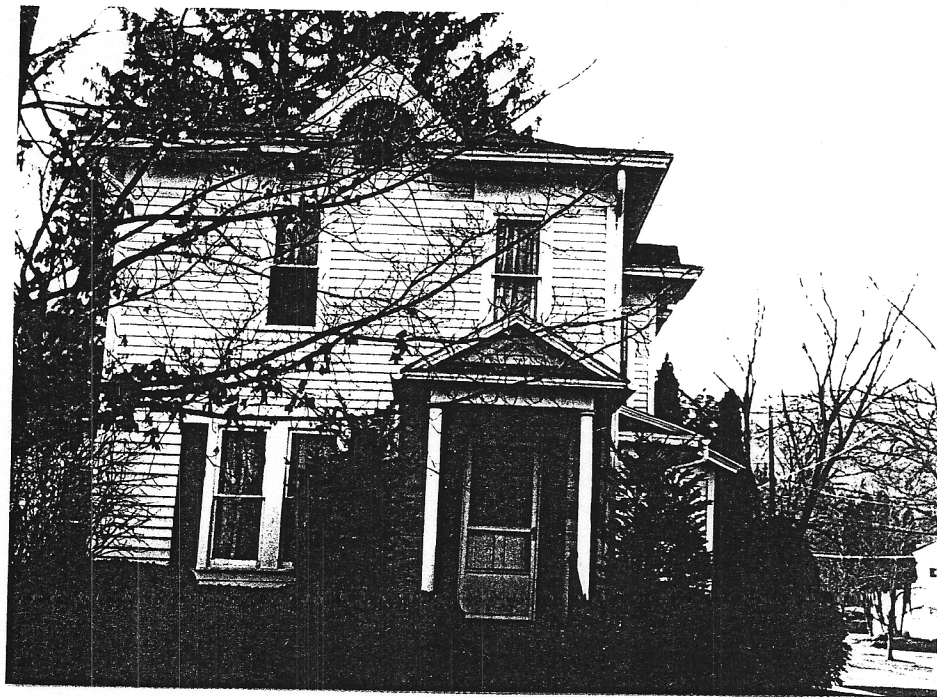
98 West 57h

This structure has an overall Italianate massing with some stylistic elements from the Folk Victorian Style. The massing consists of two intersecting box-shaped structures with intersecting moderately pitched hipped roofs. There is a small one-story projecting wing on the east side of the house and a single-story bay window on the west side.

The front (north) facade has asymmetrical window placement and a pedimented single-story portico located on the west side. The rear (south) of the house has a single-story enclosed porch attached. There is a tall thin window with a rounded molding located on the second story that may be a remnant of an original Italianate-style window.

On the east, west, and north sides of the house there are triangular dormers with decorative detailing. Other decorative features include small multi-light windows located on the east and west sides of the house. The house has a brick ridge chimney,
