**BUILDING-STRUCTURE INVENTORY FORM**

ORGANIZATION (if any): Preservation Planning Workshop, Cornell University

Continuation Sheet, Page 1  
124 East First Street  
Corning, New York

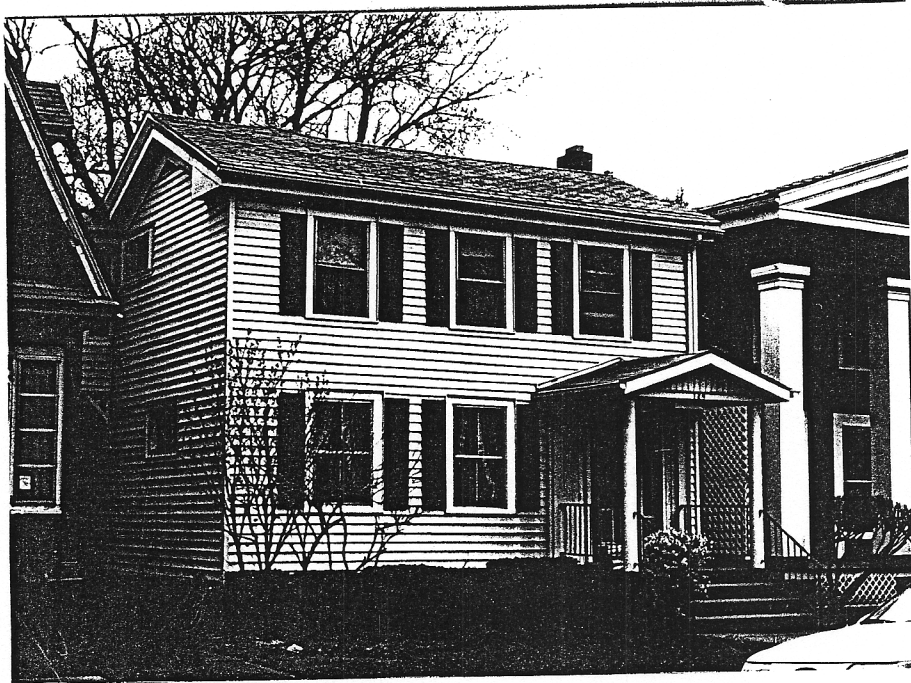
124 East First Street is an example of a transitional Federal Style/Greek Revival residence found in Corning. The massing is characterized by a two-story rectangular block that is very deep and three bays wide. A one story wing is located on the rear (south) facade of this building. A shallow projecting bay, supported by decorative brackets, is located on the second story of the east facade. The roof is covered in asphalt composition shingles. The original foundation is concealed by concrete, probably added as a repair measure. Federal Style elements of this house include the three-bay symmetrical arrangement of the principal facade, the ridge of the low-pitched roof running parallel to the street, the end wall chimney visible on the west elevation, and the decorative door surround consisting of recessed sidelights. The most prominent surviving Greek Revival element is the cornice returns. The present front-gabled entrance portico likely replaced a one-story porch common in Greek Revival residences. Shutters are present on the main facade.
