BUILDING-STRUCTURE INVENTORY FORM

- 1. BUILDING NAME(S): _____
- 2. COUNTY: Steuben TOWN/CITY: Corning VILLAGE: _____
- 3. STREET LOCATION: 127-129 East First Street
- 4. OWNERSHIP: a. public b. private
- 5. PRESENT OWNER: Gerald C. Early ADDRESS: _____
- 6. USE: Original: residence Present: residence
- 7. ACCESSIBILITY TO PUBLIC: Exterior visible from public road: Yes - No
Interior accessible: Explain No private residence

CONTINUATION SHEET, Page 1
127-129 East First Street
Corning, New York

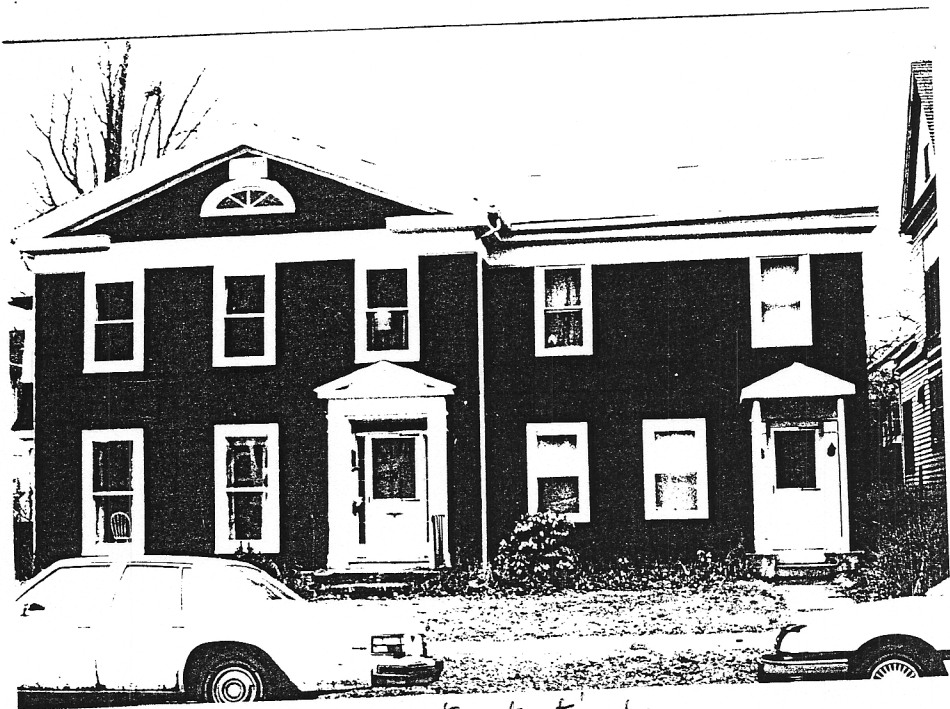
127-129 East First

A small pedimented portico, with simple square supports, has been added to the eastern entrance on the main (south) facade, both of the entry doors have also been replaced with metal doors. The house has been clad in shingles.

This structure features a low pitch cross-gabled tin roof. The front (south) facing gable is on the western half of the structure. The gable is accented with eave returns, a fan light and a continuous cornice. This wide cornice is continued across the facade. The windows on the south, east and west facades are all one-over-one double-hung sash. The windows on the north facade vary; one-over-one, two-over-two and six-over-six double-hung sash.

There are two entrance on the south facade, the one on the western portion is typical of the Greek Revival Style, featuring a pedimented entablature with square pilasters, sidelights and a narrow transom. The eastern door also features simple pilasters, but there are no sidelights or transom. A pedimented portico with narrow square columns, and a concrete stoop have been added to this entrance.
