BUILDING-STRUCTURE INVENTORY FORM

CONTINUATION SHEET, page 1
2-8 East First Street
Corning, New York

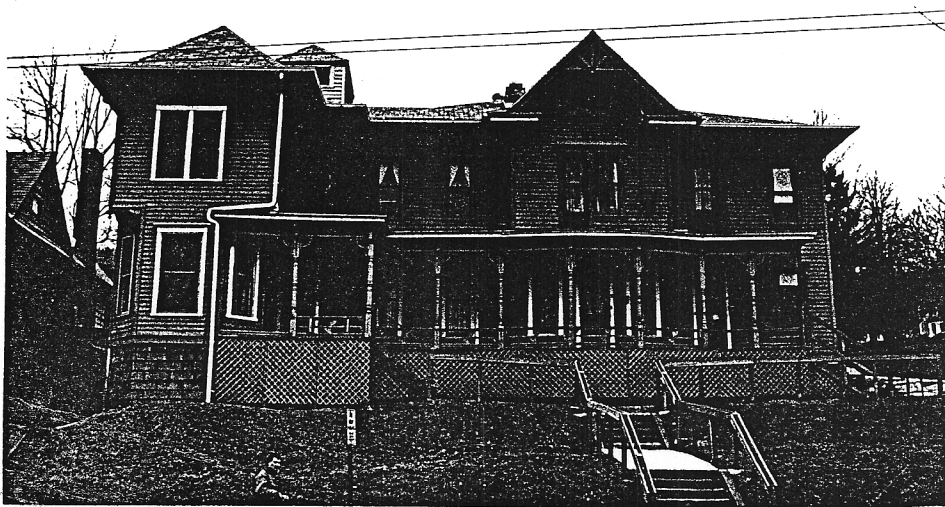
↙ 28⁸ East First (2 to 8)

This building contains an eclectic mix of elements and styles. The main block of the structure is in Italianate Style in form, with a low-pitched roof, generous overhang, and supporting brackets.

A later addition to the east (built between 1903 and 1908) has been executed in the Queen Anne Style evident in the clipped and bracketed corners. The addition repeats the overhang and brackets of the earlier building campaign. Other notable features of the house include projecting gabled pavilions with decorative stickwork and vertical siding in the gable ends on the north and west facades, an Eastlake porch which extends from the addition along the full width of the northern facade, a tower form at the intersection of the addition and the older structure, and two second story doorways on the northern facade which possibly gave access to an earlier porch. The rear of the building reveals a two-story porch with an exterior stairway.

The older portion of the building rests on a coursed stone foundation and the addition rests on a cast stone foundation. The entire building is covered in wooden clapboarding.
