BUILDING-STRUCTURE INVENTORY FORM

- 1. BUILDING NAME(S):
- 2. COUNTY: Steuben TOWN/CITY: Corning VILLAGE:
- 3. STREET LOCATION: 28 East First Street
- 4. OWNERSHIP: a. public [] b. private [X]
- 5. PRESENT OWNER: Chowning Regulator Corp. ADDRESS: 165 Cedar Street, Corning, NY 14830
- 6. USE: Original: Residential Present: Residential
- 7. ACCESSIBILITY TO PUBLIC: Exterior visible from public road: Yes [X] No []
Interior accessible: Yes [] No [X] Explain: Private Residence

CONTINUATION SHEET, page 1
28 East First Street
Corning, New York

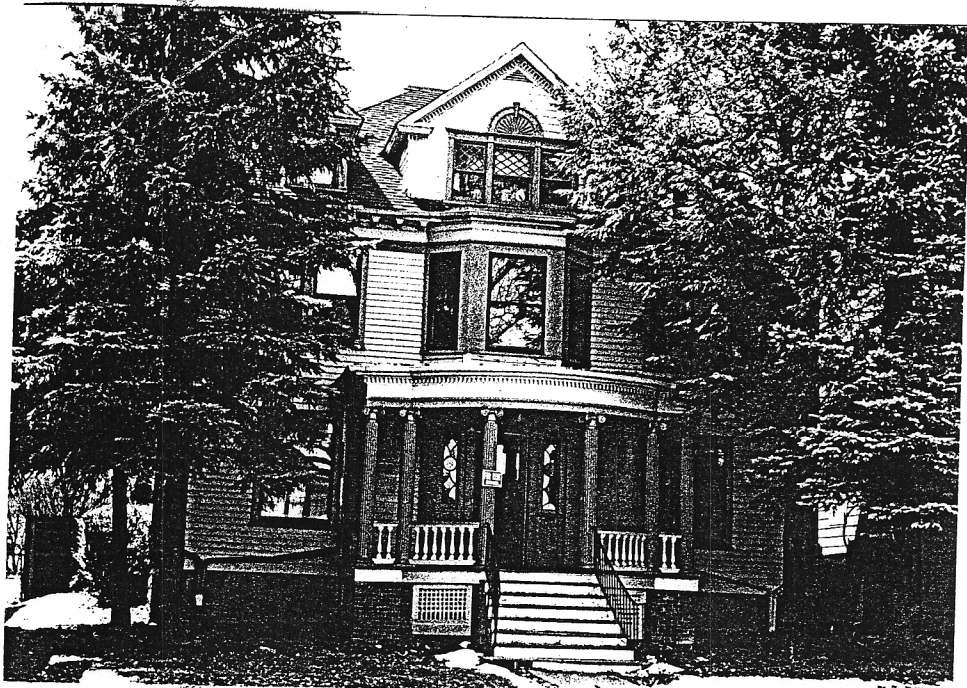
28 East First ↗

The three-family residence is cubic in form and topped by a hipped roof with closed and open gabled dormers. Windows types are highly varied and include Palladian, Queen Anne, lunette, stained glass, casements, and one-over-one double hung sash. The most notable architectural features of the building include a bowed porch supported by Ionic columns with a full entablature on the north facade, a projecting bay window on the second floor above the doorway, a central projecting dormer with a Palladian-style window, and two smaller dormers which are flanked by Ionic pilasters. The rear of the house is made up of a projecting wing with an attached a one-story modern addition. The modern addition features a bowed glazed gable above casement windows and skylights. The addition is topped by a roof form which extends outward further at the peak than at the eaves. A large three car garage with a gambrel roof is found on the alley side of the property. The garage appears to have been recently constructed.
