BUILDING-STRUCTURE INVENTORY FORM

- 1. BUILDING NAME(S):
- 2. COUNTY: Steuben TOWN/CITY: Corning VILLAGE:
- 3. STREET LOCATION: 34 East First Street
- 4. OWNERSHIP: a. public[] b. private [X]
- 5. PRESENT OWNER: Dominic and Jean Asiello ADDRESS: 38 East First Street
- 6. USE: Original: residence Present: residence
- 7. ACCESSIBILITY TO PUBLIC: Exterior visible from public road: Yes(X) No()

CONTINUATION SHEET. Page 1 38 East First Street Corning, New York

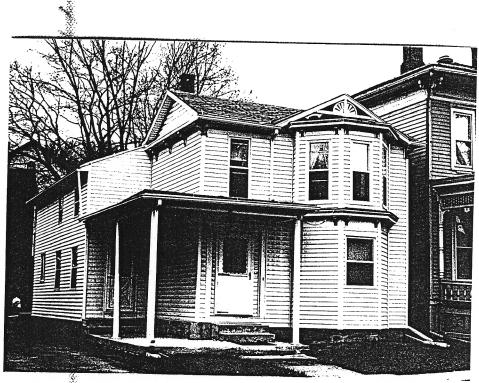
34 E. 1ST

This house is designed in the Italianate style of architecture. As noted in A Field Guide to American Houses (McAlester). the residence's identifying features include: two stories, rectangular, block-like massing of the northern half of the building; a low-pitched roof with overhanging eaves having decorative brackets beneath; and tall, narrow windows on the second story.

Both stories are covered in aluminum siding. The principle, north facade exhibits a two-story, apse-like bay. The bay is highlighted by a cross gable which is ornamented with cross bracing incorporated into a sunburst motif.
