BUILDING--STRUCTURE INVENTORY FORM

YOUR NAME: John R. Steinmeyer
YOUR ADDRESS: 106 W. Sibley Hall, Ithaca, NY
ORGANIZATION (if any): Cornell University

- 1. BUILDING NAME(S):
- 2. COUNTY: Steuben TOWN/CITY: Corning VILLAGE:
- 3. STREET LOCATION: 54 East First Street
- 4. OWNERSHIP: a. public[] b. private [X]
- 5. PRESENT OWNER: Albert J. Berleue ADDRESS: 54 East First Street
Corning, NY 14830
- 6. USE: Original: residence Present: residence, commercial
- 7. ACCESSIBILITY TO PUBLIC: Exterior visible from public road: Yes[X] No[]

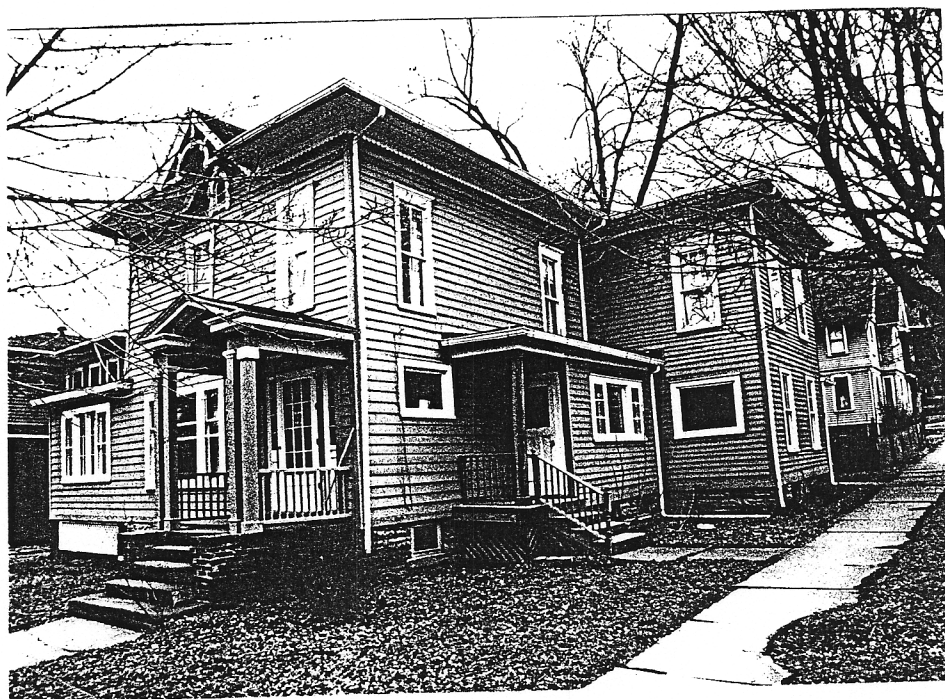
54 E. 1ST

This house is designed in the Italianate style of architecture. The structure's identifying features, as noted in A Field Guide to American Houses (McAlester), include: two stories; a low-pitched, hipped roof with widely overhanging eaves; and tall, narrow windows.

Both stories of 54 East First Street are covered with clapboards. The principle facade's horizontal roof plane is interrupted by a small cross gable with semicircular bargeboard in its tympanum. This gable highlights an arched attic window. The undersides of all of the structure's eaves are ornamented with a course of dentils and a course of decorative, fishscale detailing.

The structure has received several one and two story additions on its east, west, and south facades. Most of this building activity occurred between 1888 and 1930. The types of detailing on the additions consist of ornamental brackets on two, first-story bays, decorative window trim, and the execution of simple, geometric woodwork on wall surfaces.
