BUILDING STRUCTURE INVENTORY FORM

YOUR NAME: Marisa Lopez
YOUR ADDRESS: 106 W. Sibley Hall, Ithaca, NY
ORGANIZATION (if any): Cornell University

- 1. BUILDING NAME(S):
- 2. COUNTY: Steuben TOWN/CITY: Coming VILLAGE:
- 3. STREET LOCATION: 87 East First Street
- 4. OWNERSHIP: a. public [] b. private [X]
- 5. PRESENT OWNER: Donald B. Creath or Don Croth,
EDC Management Company
ADDRESS: ~~800 East Jeffrey Street, app. 102, Boca Raton, Florida, 33487~~ or 101 Columbia Street, Coming
Present: Residential
90 EDC Management Co.
- 6. USE: Original: Residential Present: Residential
- 7. ACCESSIBILITY TO PUBLIC: Exterior visible from public road: Yes [X] No []
Interior accessible: Yes [] No [X] Explain: Private Residence

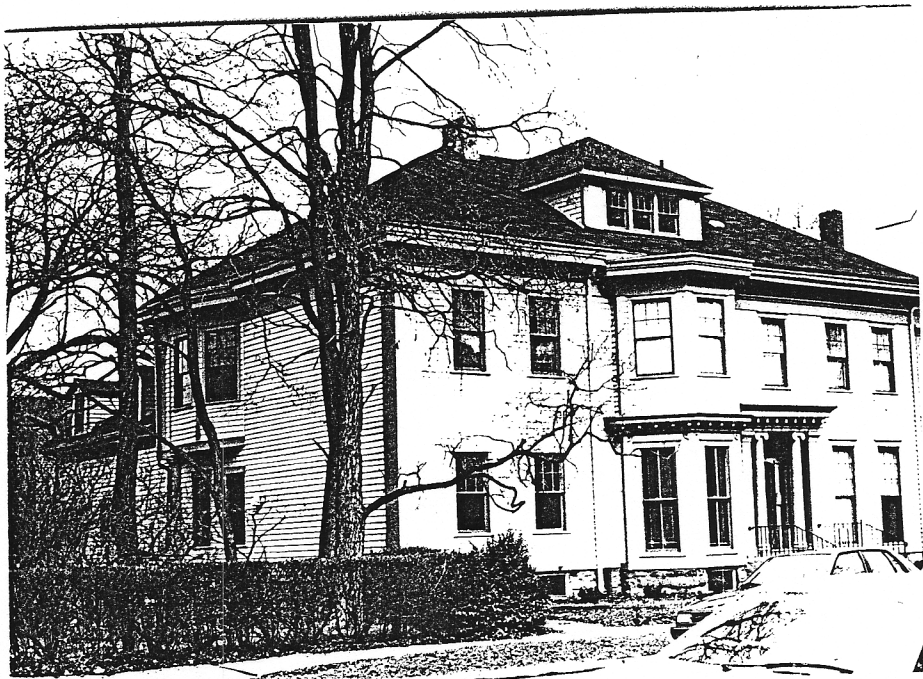
87 East First

A modified Greek Revival-style structure, this multi-unit, two-and-a-half stories building, has corner pilasters and a wide-band cornice beneath a low, hipped roof. The siding is clapboard and the main (south) entrance is recessed in an elaborate, decorative surround under a bracketed lintel. Free standing Ionic columns between Doric pilasters complete the doorway surround. The door has sidelights and a toplight. To the west of the main entrance is a two-story projecting bay, the first-story of which features Italianate-style detailing and long, narrow two-over-two windows. A hipped dormer is centered on the roof and it has a trio of windows with three-over-one sash. The building rests on a stone foundation. The west facade has a one-and-a-half story addition to the north (rear of the site) with gabled roof. There is also a second story bay window on the north facade. The north facade (to the rear of the site) is complicated by projecting additions of varying

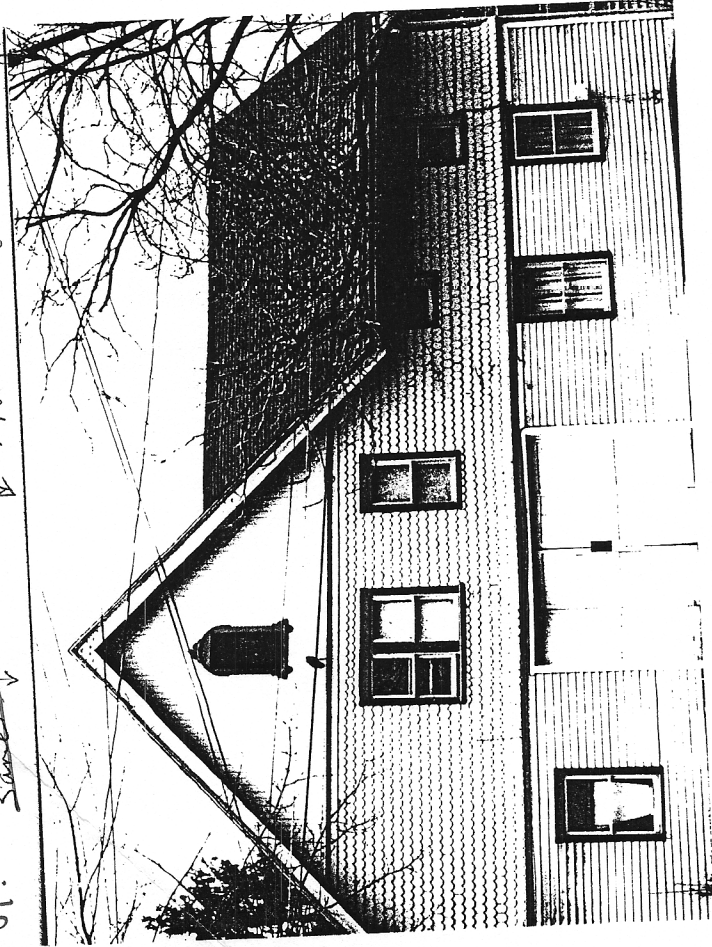
Outbuilding

heights, exterior stairways and shed dormers. The carriage house to the rear of the site is one-and-a-half-stories in height and has a box-like floor plan and a gambrel roof with centered cross-gambrels on a north-south axis. A centered cupola on the ridge completes the design of the roof. It has clapboard siding and composite roof shingles. The north facade of the carriage house has four wide carriage entrances. The south facade has four paneled doors with nine panes of fixed glazing.
