**BUILDING-STRUCTURE INVENTORY FORM**

- 1. BUILDING NAME(S):
- 2. COUNTY: Steuben TOWN/CITY: Coming VILLAGE:
- 3. STREET LOCATION: 89 East First Street
- 4. OWNERSHIP: a. public [ ] b. private [X]
- 5. PRESENT OWNER: Dr. Indira Sharma  
ADDRESS: 6 Overbrook Drive, Painted Post, NY
- 6. USE: Original: Residential Present: Rental dwelling
- 7. ACCESSIBILITY TO PUBLIC: Exterior visible from public road: Yes [X] No [ ]  
Interior accessible: Yes [ ] No [X] Explain: Private Residence

Continuation Sheet, Page 2  
89 East First Street  
Corning, New York

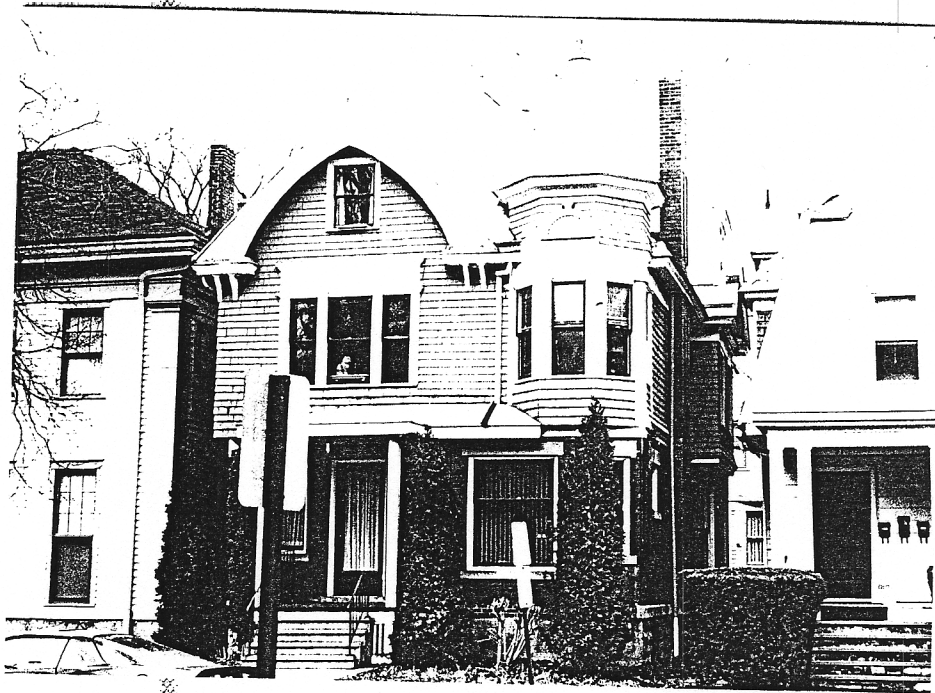
89 East First

An example of the so-called "Free Classic" Queen Anne Style of architecture (see V. & L. Mc Alester, Field Guide to American Houses), this structure has a lower story constructed of brick with the upper stories clad in wood shingles. The dominant features of the asymmetrical main facade are a second story turret on the south east corner, the pointed vergeboard in the front gable end and the hipped roof. A replacement porch with a shed roof shelters the main entrance. The Queen Anne windows in the brick first story are placed singly and have simple stone lintels and sills, whereas the windows in the upper stories are in groups or bands topped by panels with classical swags as detailing. The tall chimney on the east side is another Queen Anne-style element. There are two shed dormers on the east side of the gabled roof. The north facade is complicated with a variety of additions including an enclosed porch and stairway. The house is set on a stone foundation and has an asphalt shingle roof.
