BUILDING-STRUCTURE INVENTORY FORM

STREET LOCATION: 102 East Fourth Street 3.

CONTINUATION SHEET, Page 1 102 East Fourth Street Corning, New York

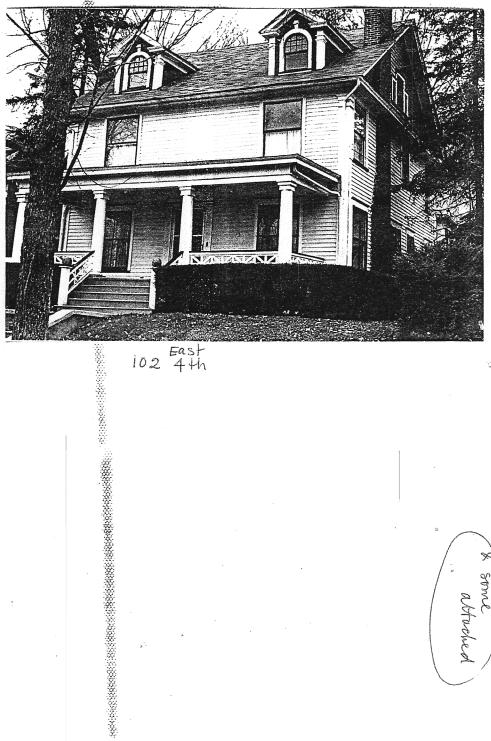
102 Fast

The main (north) facade is dominated by the full-width porch. While supported by four Tuscan columns, the porch is also decorated with a stick-style rail reminiscent of the Queen Anne stylistic vocabulary. The decorated hood over the main entrance and very wide one-over-one double-hung sash, used in the upper and lower stories, are more characteristic of Colonial Revival Style. Twin dormers are found on the north slope of the side gabled roof; these gabled dormers are decorated with a broken pediment and pilasters on the front surface. A rounded top single-hung sash ornaments the dormer end. There is multi-pane glazing (twelve lights) in the upper sash. An accentuated keystone completes the Colonial Revival decoration in the dormers. However, the wall surfaces of the dormer is clad with wood shingles. This is decidedly Queen Anne in style. The east and west facades feature the gable ends. These gable ends are clad in wood shingles, again Queen Anne, but are pierced by a Colonial Revival three-part Palladian window. Various sized one-over-one double hung sash are used over the west, south, and east facades. The south slope of the roof features a single shed dormer containing an eight-light casement window. At the south end of the east facade there is another entrance. Over this entrance is a simple hood supported by triangular brackets. Above this hood is a cottage window carrying a ten-pane header.

The house sits on an irregularly-coursed, rough-cut sandstone foundation. The first two stories of the house are clad with clapboard siding. The gable ends use rectangular wood shingles instead. The roofing of the house and garage is asphalt shingles. The gable-roofed wood-frame garage rests on a poured concrete foundation The garage is also clad with clapboard.
