BUILDING-STRUCTURE INVENTORY FORM

YOUR NAME: Eric P. Avner
YOUR ADDRESS: 106 W. Sibley Hall, Ithaca, NY
ORGANIZATION (if any): Cornell University

- 1. BUILDING NAME(S):
- 2. COUNTY: Steuben TOWN/CITY: Corning VILLAGE:
- 3. STREET LOCATION: 121 East Fourth Street
- 4. OWNERSHIP: a. public [] b. private [X]
- 5. PRESENT OWNER: Mason A. & Barbara J. Coger ADDRESS: Same as above
- 6. USE: Original: Single-family residence Present: Single-family residence
- 7. ACCESSIBILITY TO PUBLIC: Exterior visible from public road Yes[X] No []
Interior accessible: Yes [] No [X] Explain: Private Residence

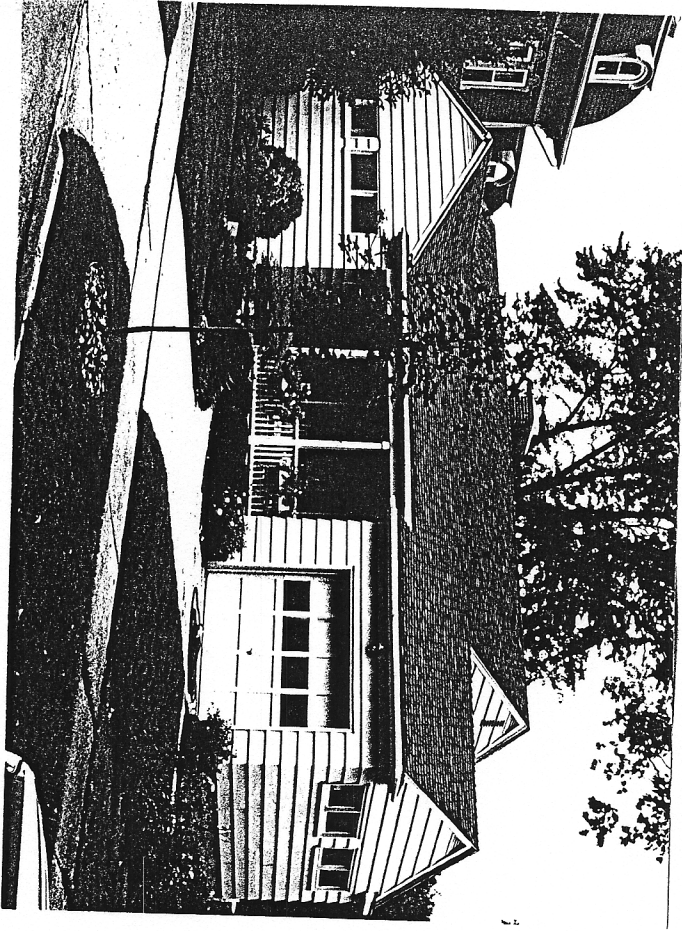
121 E. 4th

The south (main) facade of the house is dominated by the horizontal band of awning windows on the cross-gable end. The south facade of the garage the wall plane formed by the cross-gable end. Interrupting this plane is a recessed, poured-concrete entrance patio. The two-story north facade is notable for its repeated use of window groupings, each consisting of four awning windows, arranged in a square pattern. Due to the sloping site, one has direct access to the basement level from grade. The aforementioned unused side entrance is located on the east facade. The east exterior wall of the garage uses the same window vocabulary as does the south facade.

The foundation of this structure is poured concrete. The wood forms used in this process have left visible imprints in the hardened concrete. Each of the basement well windows on the east and west facades have a center clear light flanked by two columns of glass blocks.
