BUILDING-STRUCTURE INVENTORY FORM

- 1. BUILDING NAME(S):
- 2. COUNTY: Steuben TOWN/CITY: Corning VILLAGE:
- 3. STREET LOCATION: 122 East Fourth Street
- 4. OWNERSHIP: a. public [] b. private [X]
- 5. PRESENT OWNER: John M. & Mary A. Kelly ADDRESS: Same as above
- 6. USE: Original: single-family residence Present: single-family residence
- 7. ACCESSIBILITY TO PUBLIC: Exterior visible from public road Yes[X] No []
Interior accessible: Yes [] No [X] Explain: Private Residence

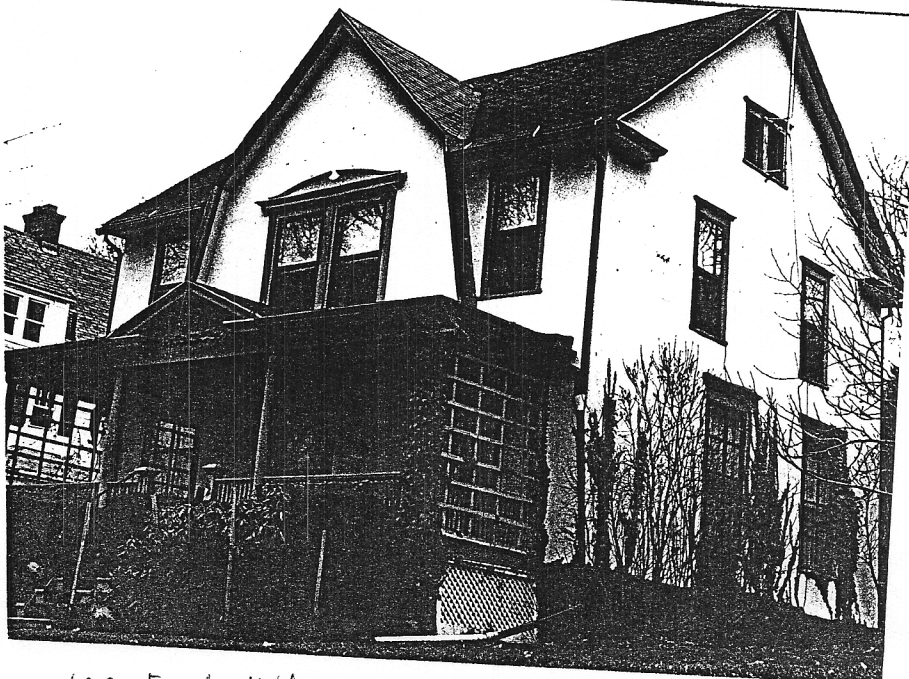
122 East 4th

This two-story structure can be described as having a side-gabled roof with front facing gambrel roof and cross gable at the rear. This house exhibits many of the identifying characteristics of the Colonial Revival Style, Gambrel subtype, as presented in the McAlesters' book *A Field Guide to American Houses*. These include an accentuated front door; steeply pitched roof; windows with double-hung sash, usually with multi-pane glazing in one or both sash; and the windows frequently in adjacent pairs. This particular design was a popular pattern-book design during the period from about 1905 to 1915. The full-width front porch with center broken pediment is typical of the pattern-book model.

The front (north) facade is dominated by the full-width porch, with its square ballusters and pediment over the steps. The tympanium of the pediment is decorated with a garland and swag motif. Also of significance on the north facade is the front-facing gambrel gable. The centre of the gambrel contains a pair of one-over-one windows, surrounded by decorative frame and broken pediment hood. It is interesting to note that the upper and lower story windows are not aligned, nor are their respective sizes similar. The east and west facades are the gable ends of the side gable. Each features a variety of irregularly placed one-over-one double-hung windows. The gable peaks feature recessed casement windows surrounded by a wide wood frame. The south facade of the house is dominated by a cross gable from the eastern two-thirds of the facade. The gable peak and the remainder of the gable end features a variety of one-over-one double hung windows, in an irregular arrangement.

The house sits on an irregularly-coursed, fieldstone foundation. It is speculated that the original siding of the house was clapboard, due to this style's popularity with that cladding in the period pattern-books. It is estimated that the stucco was applied in the 1920s as a renovation. It is interesting to note that this house's stucco was applied in sheets, instead of over the customary mesh. As a result of this construction method, cracks are visible around each of the said sheets of stucco. The garage at the rear of the site is a wood-framed, hipped-roof structure resting on an irregularly coursed stone foundation.
