BUILDING-STRUCTURE INVENTORY FORM

ORGANIZATION (if any): Preservation Planning Workshop, Cornell University

- 1. BUILDING NAME(S):
- 2. COUNTY: Steuben TOWN/CITY: Corning VILLAGE:
- 3. STREET LOCATION: 127 East Fourth Street
- 4. OWNERSHIP: a. public [] b. private [X]
- 5. PRESENT OWNER: Burdette B. & Janet C. Gleason ADDRESS: 127 East Fourth Street
- 6. USE: Original: Residence Present: Residence
- 7. ACCESSIBILITY TO PUBLIC: Exterior visible from public road: Yes [X] No []
Interior accessible: Yes [] No [X] Explain: No, private residence

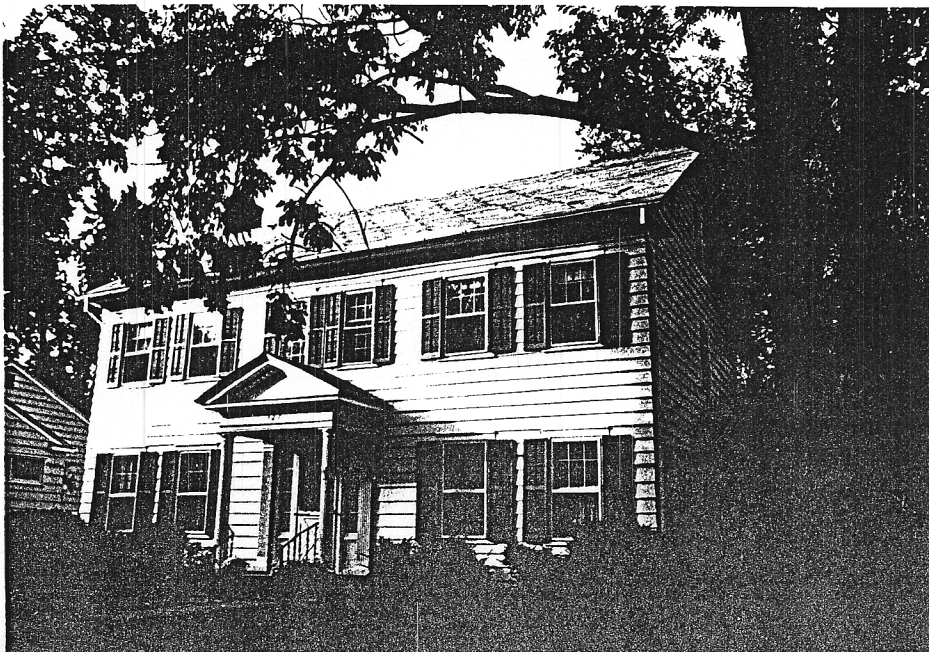
127 East Fourth Street is a rectangular, two-story, side-gabled, five-bay Colonial Revival-style house. Roughly twenty-five percent of this style have a side-gabled roof; this subtype predominates after 1910. The Colonial Revival style was popular in America from 1880 to 1955, and in New York State between 1880 to 1930 or later. According to Virginia and Lee McAlester's *A Field Guide to American Houses*, principal characteristics of Colonial Revival-style houses include elaboration of entrances, cornices, and windows. Broken pediments, multiple-light sashes, double, triple, and Palladian-style windows are common. Revivals of the Georgian and Federal (Adam) styles are the most common, followed by Dutch Colonial and Post-medieval English styles.

The projecting entry porch on the front (south) facade of 127 East Fourth Street consists of two fluted pilasters, two fluted Doric columns, an entablature decorated with dentils, and a pediment. Dentils surround all three sides of the recessed central plane of the pediment. Sidelights surround the door. There are two first-story windows and two second-story windows on both sides of the entry porch. They are all six-over-one light double-hung sash. Above the entry porch, there are two narrow, six-over-six light double-hung sash. All windows on this facade have wooden shutters.

There is a small entry porch with latticework skirting on the east facade. An exterior chimney is located on the west facade, with quarter-circle lunettes on either side of the chimney. Also on this facade, there are four pairs of eight-light windows, two six-over-nine light double-hung sash, and several six-over-one light double-hung sash. A first-floor addition is on the north facade. It has a shed dormer, two bands of triple one-light windows, and a band of four one-light windows. A concrete one-and-a-half story, gabled (with pent returns), wood flushboard, two car garage is located to the rear (north) of the house.
