**BUILDING-STRUCTURE INVENTORY FORM**

YOUR NAME: Jennifer L. Baskerville      DATE: December 11, 1992  
YOUR ADDRESS: 106 W. Sibley Hall      TELEPHONE: (607) 255-6851  
ORGANIZATION (if any): Preservation Planning Workshop, Cornell University

- 1. BUILDING NAME(S):
- 2. COUNTY: Steuben      TOWN/CITY: Coming      VILLAGE:
- 3. STREET LOCATION: 29 West Fourth Street
- 4. OWNERSHIP: a. public [ ] b. private [ X ]
- 5. PRESENT OWNER: Everett N. and Brenna S. Larson      ADDRESS:
- 6. USE:      Original: Residence      Present: Residence
- 7. ACCESSIBILITY TO PUBLIC:      Exterior visible from public road: Yes [ X ] No [ ]  
Interior accessible: Yes [ ] No [ X ] Explain: Private residence

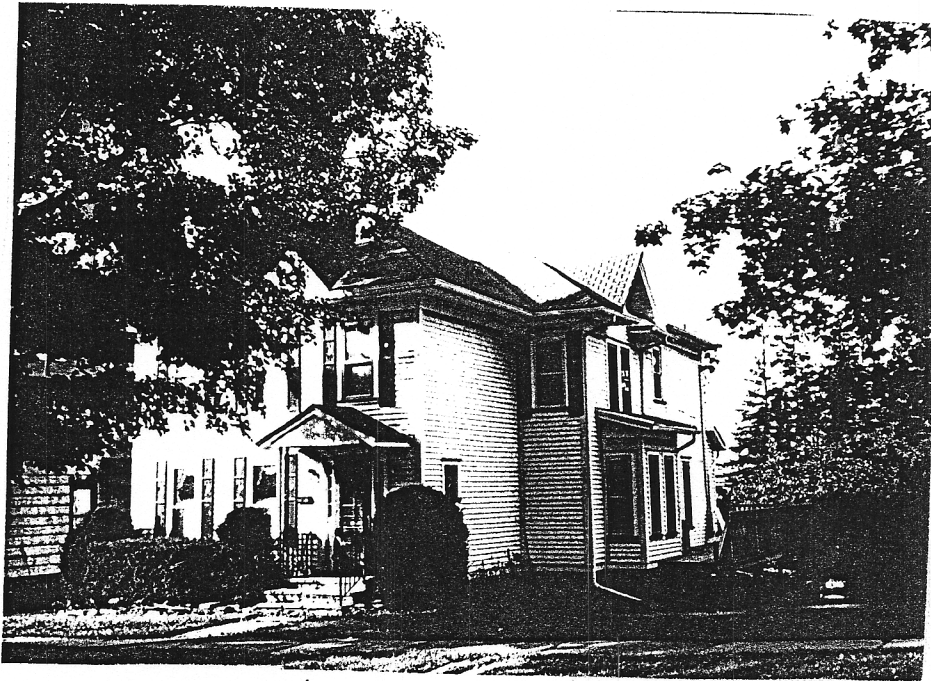
↶ 29 West 4th

The front (south) facade is three bays wide with the entrance located in the third, or easternmost bay. The door is framed by four-light side lights and topped by a pedimented entrance canopy supported by wrought iron supports which rise from the stair railing, also in wrought iron. The second level of the south facade contains three windows. All windows on this facade are one-over-one-light double-hung sash and have wood shutters with heart cut-outs.

The east facade has a center gable similar to the one on the south facade. There is a squared bay window on the first level with one-over-one-light double-hung windows on the outer sections, and a double one-over-one-light double-hung window in the center (facing east). There is a one-over-one-light window on the second level facing south. A wood deck wraps around the east and north facades of the house.
