BUILDING-STRUCTURE INVENTORY FORM

YOUR NAME: Lex Campbell
YOUR ADDRESS: 106 W. Sibley Hall, Ithaca, NY
ORGANIZATION (if any): Cornell University

CONTINUATION SHEET, Page 1
60 East Fourth Street
Corning, New York

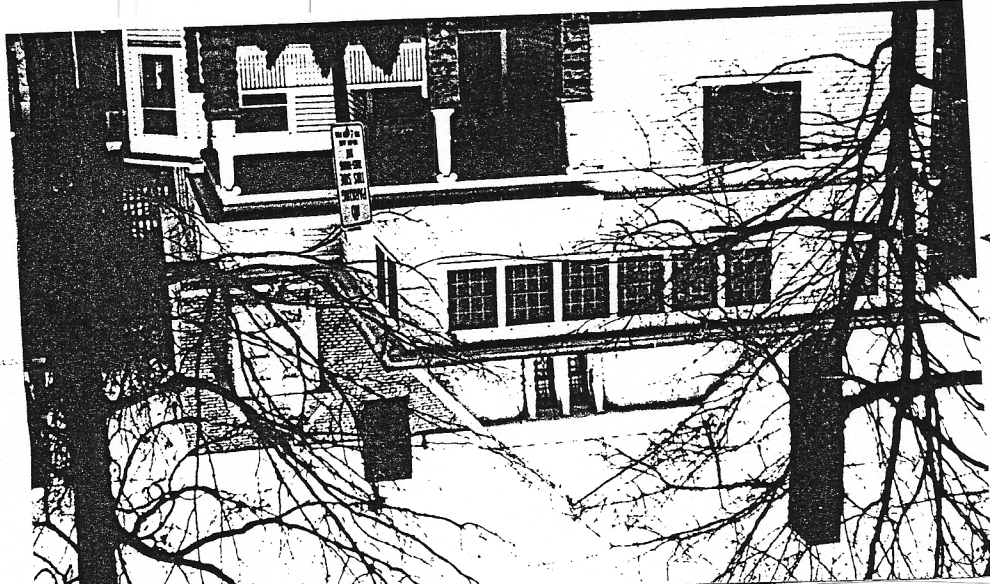
West Facade

The west facade has a window extraordinary character. its wood casind is archedwith swags cut into it. Three circulat windows top three rectangluar diamond-glazed stained-glass windows.

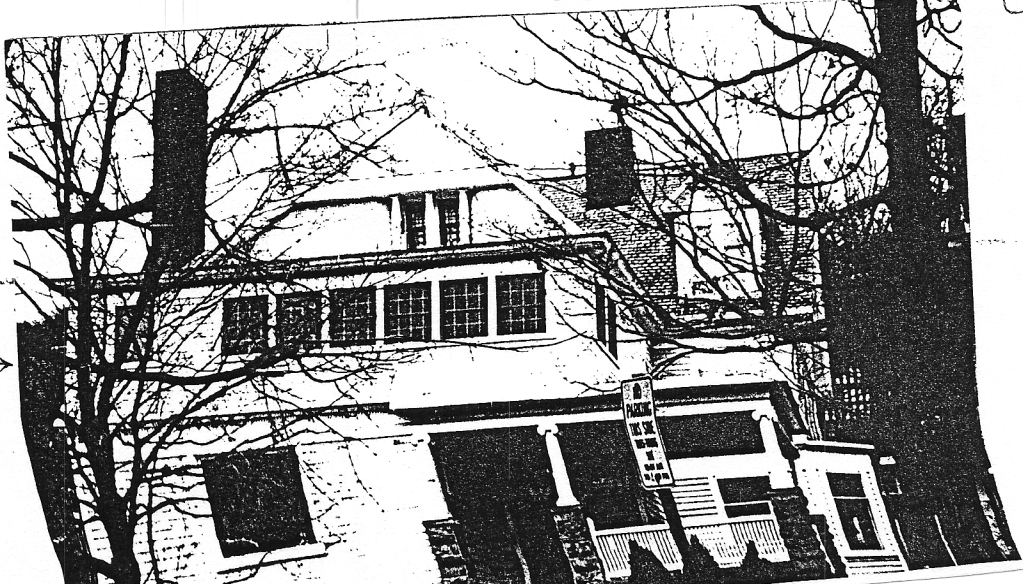
East Facade

The east facade has some notable features. What is most prominent is the asymmetrical front-gable that is covered by coursed wood shingles. A small 2 / 2 double hung sash window on the second-story is of interest. It is accentuated by a decorative pediment. On the third story, a recessed band of windows are further emphasized by four colonetes that are located in the space.
