CONTINUATION SHEET, Page 1

61 West Fourth Street

Corning, New York

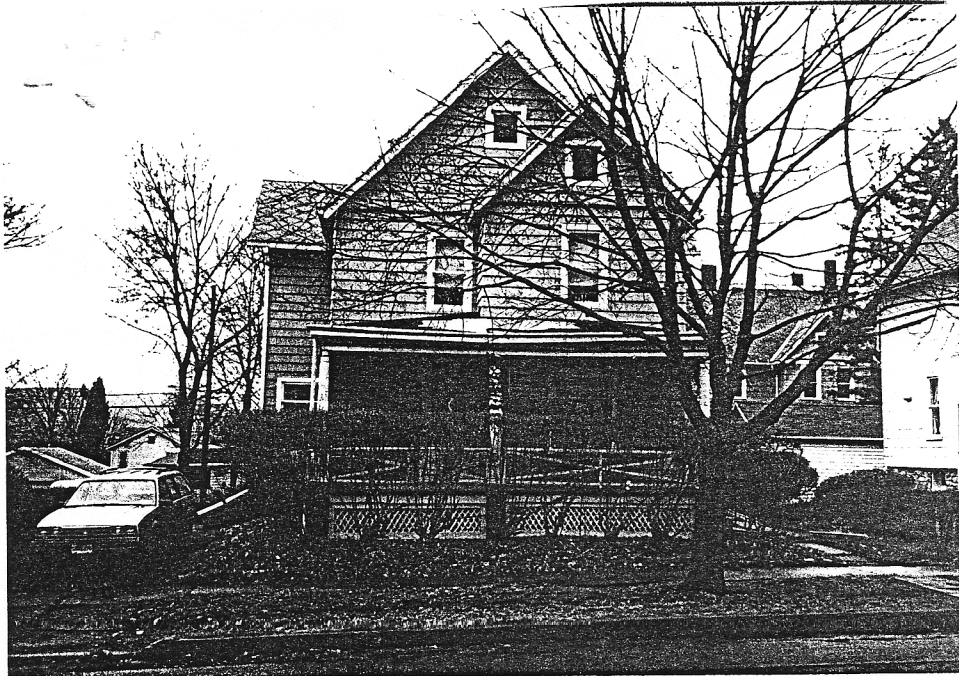
61 West 4th

This two-story house is designed in the Queen Anne Style of architecture. In their book, A Field Guide to American Houses, the McAlester's would refer to this as a cross-gabled "Free Classic" example of the style. The house exhibits many features associated with the style, including a front facing gable with a lower front gable on the primary facade, and a rear cross-gable.

This house is covered in wood shingles and has small gable end windows. The windows are paired on each level. The primary entrance is located on the front-facing gable and is accessed through a one-story full width front porch. This porch has a flat roof and is supported by stylized columns with a frieze. The balustrade of the porch has been removed and been replaced with plain wood members. Front door asymmetrically located to the west side of the primary facade.

The garage which is located at the north end of the lot is a single story hipped roof structure finished in wood shingles as well. The foundation of this house is partially-raised, made of a rough cut bedstone.
