CONTINUATION SHEET, Page 1

65 West Fourth Street

Corning, New York

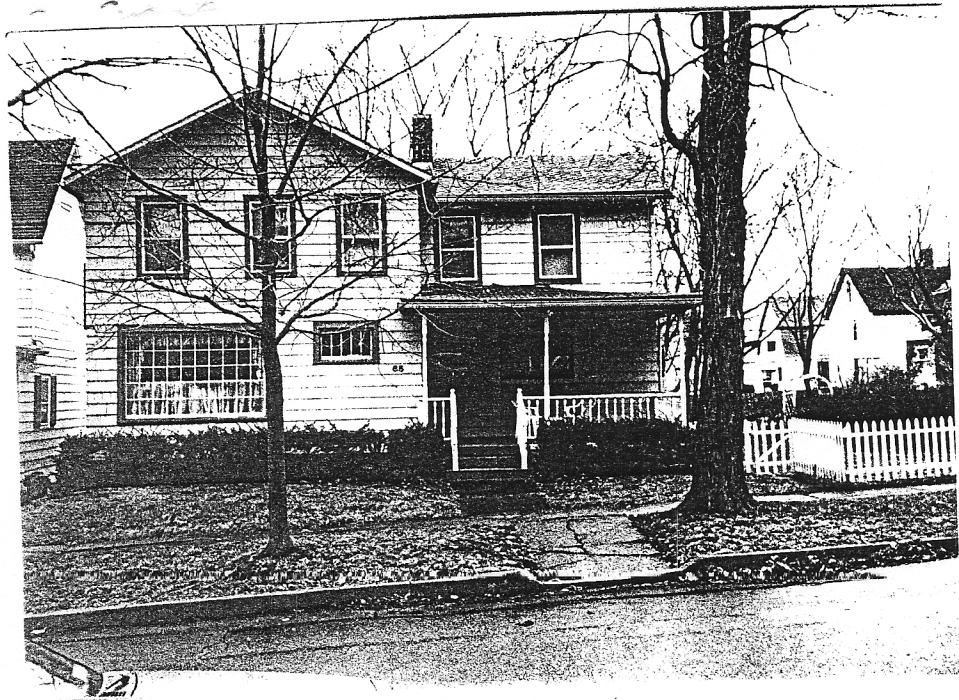
71

This two-story cottage type home is built in the Folk Victorian Style of architecture as identified in the McAlester's book A Field Guide to American Houses. This house exhibits many features associated with this style including a front facing gable and a side wing.

This house is finished in wood shingle siding with the primary entrance located on the east side of the front facing gable. There are double-paned on the top story of both the front gable and the side wing. On the lower level of the house there is a large picture window, not original to the house and a smaller rectangular window. These windows are also on the lower level of the side ell of the structure. There is a one-story porch located on the side wing of the house. This porch has a simple hipped roof which is supported by turned posts. The balustrade of this porch is also made up of turned posts as well. The house has a centrally located brick chimney.
