# BUILDING-STRUCTURE INVENTORY FORM

2. STREET LOCATION: 67 West Fourth Street 3.

22. THEME: CONTINUATION SHEET, Page 1 67 West Fourth Street Corning, New York

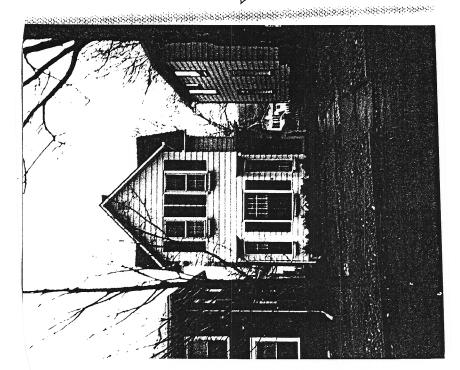
LGT West 4th

This two-story home is designed in the Queen Ame style of architecture. In their book, <u>A Field Guide to American Houses</u>, the McAlesters would refer to this as a cross-gables subtype with "Free Classic" detailing. This house exhibits many features typical of this style, including a steeply pitched gabled roof and an asymmetrical principle facade.

This home is finished with a wood shingled siding; there is a full front gable which forms an L-shape with a side gable in the rear of the house. The recessed primary entrance is located to the east side of this gable. On the first story of the house, the corners of the front facing gable are canted with rounded decorative pieces hanging down. The windows on the both the first and second story of the are six-over-six windows.

This house sits on a partially-raised foundation made of a rough-cut bedstone.
