BUILDING-STRUCTURE INVENTORY FORM

- 1. BUILDING NAME(S):
- 2. COUNTY: Steuben TOWN/CITY: Corning VILLAGE;
- 3. STREET LOCATION: 74 East Fourth St.
- 4. OWNERSHIP: a. public [] b. private [x]
- 5. PRESENT OWNER: Takeo and Nasako Takemasa ADDRESS: 74 East Fourth St.
- 6. USE: Original: Single family residence Present: Single family residence
- 7. ACCESSIBILITY TO PUBLIC: Exterior visible from public road Yes[x] No []
Interior accessible: Yes [] No [x] Explain: Private Residence

CONTINUATION SHEET, Page 2
74 East Fourth Street
Corning, New York

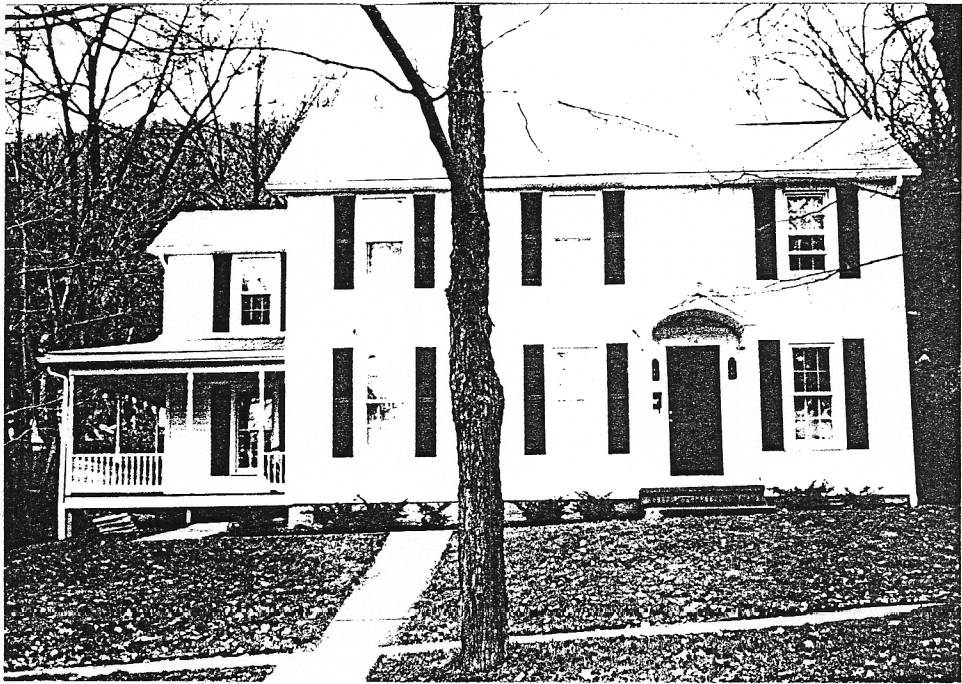
C 74 East 4th

This house at one time probably appeared as a vernacular cottage. It now has accumulated elements of the Colonial Revival style. The home is side-gabled. Its massing is somewhat awkward. A small bay is connected to the main house in the rear and extends out to the left side. This bay is also side-gabled.

The front door of the home is accentuated with a decorative crown and pediment. Pilasters extend up from the small entry porch to support the crown. The main bay of the home has six identical windows with double-hung sashes and multi pane glazing. There are three windows on each floor. They are spaced unevenly to allow for the front entryway. A porch extends around the north and east side of the rear bay. Though the Sanborn map indicates an original porch here this one is newly constructed. It has turned balusters and porch supports.

Many of the elements on the exterior of the home are modern materials. The siding and shutters are vinyl. The foundation to the original structure is siltstone. Concrete was used for the addition's foundation.
