BUILDING-STRUCTURE INVENTORY FORM

YOUR NAME: Nicole Stull
YOUR ADDRESS: 106 W. Sibley Hall
ORGANIZATION (if any): Cornell University, Preservation Planning Workshop
DATE: Fall 1993
TELEPHONE: (607) 255-4331

75-77 West Fourth Street

Corning, New York

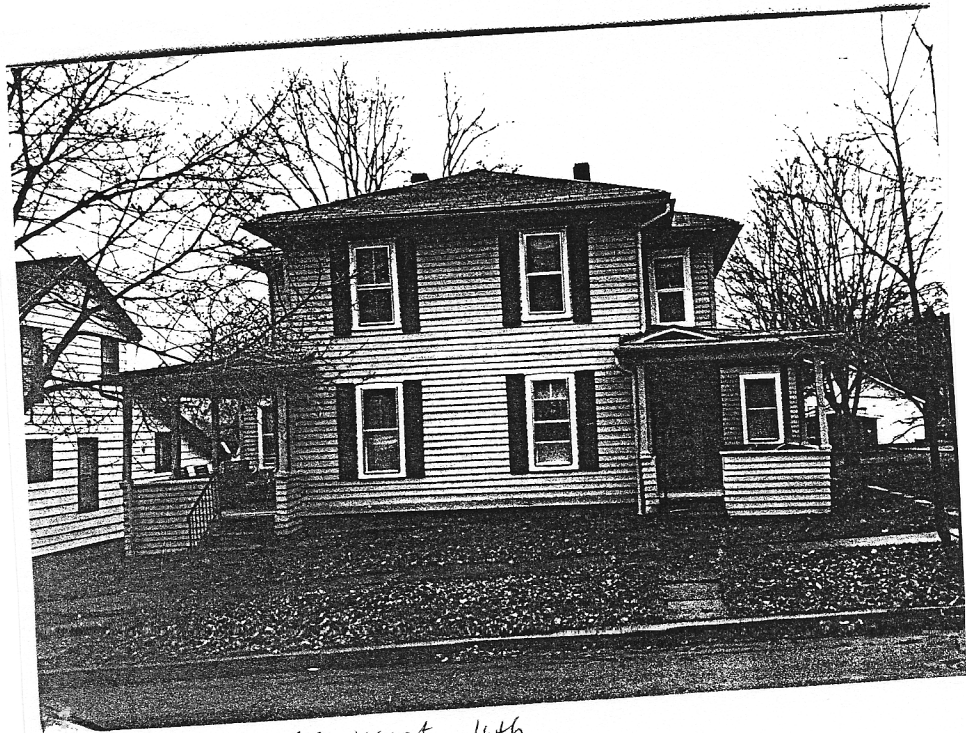
75-77 West 4th

This two-story structure is designed in the Italianate Style of architecture and exhibits many qualities associated with this style. For example, it is box-like in massing, symmetrical in form and has a very low pitched, simple, hipped roof.

The house has clapboard siding and paired Italianate-style windows on both stories. There are two single-story side porches, to either side of the house, with pedimented entryways and column-like posts supporting the roof. The shingled roof has very wide, overhanging eaves. A number of the decorative features, such as brackets and window hoods, typically associated with the Italianate Style are no longer present.

There is a one-story shed with a hipped roof at the north end of the lot, finished in the same siding as the main house. The house sits on a partially-raised foundation which is made of poured concrete.
