CONTINUATION SHEET, Page 1

85 West Fourth Street

Corning, New York

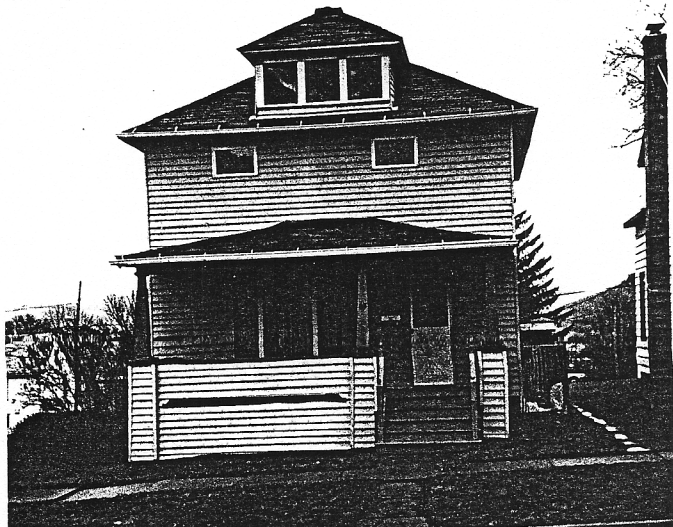
85 West 4th

This two-and-a-half-story home is designed in the American Foursquare Style of architecture which was very popular in the early twentieth century. This house exhibits many features typically associated with this style, including its unpretentious square, box-like form.

This house is finished in same aluminum siding. The structure has a hipped roof with wide overhanging eaves, a central chimney and a roof dormer. There is a full-width, one-story porch, which appears to have been enclosed. The porch is supported by stylized column-like posts. The primary entrance is located to the east side of the primary facade. On the second story of the home there are paired small window located very close to the roof line.

The house is set on a partially raised basement which appears to be made of poured concrete.
