BUILDING-STRUCTURE INVENTORY FORM
DIVISION FOR HISTORIC PRESERVATION
NEW YORK STATE PARKS AND RECREATION
(518) 474-0479

3. STREET LOCATION: 177 Pine Street

Continuation Sheet, Page 1
177 Pine Street
Corning, New York

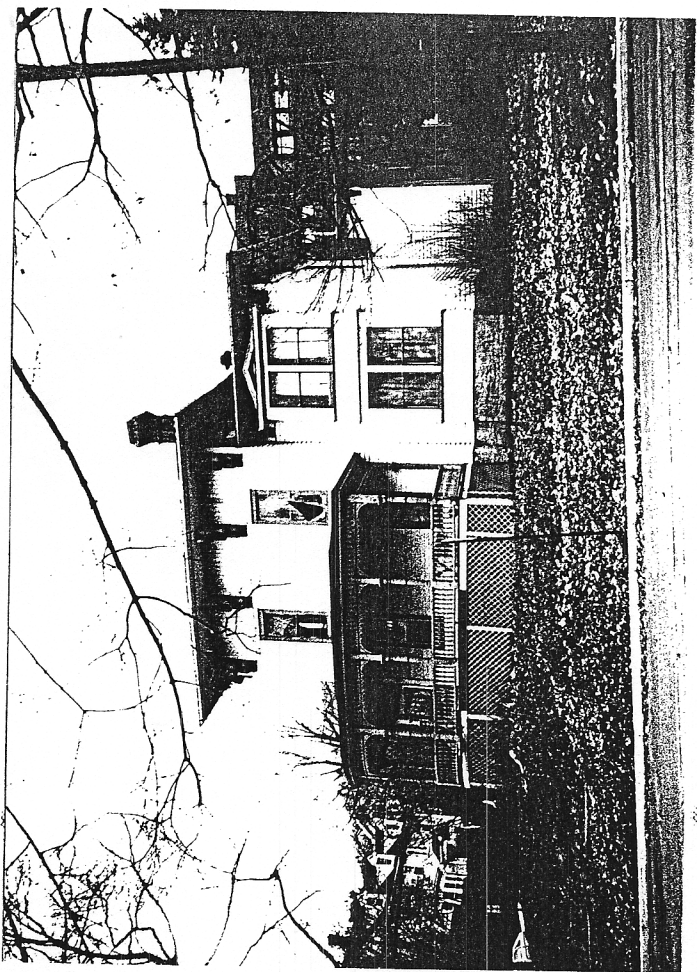
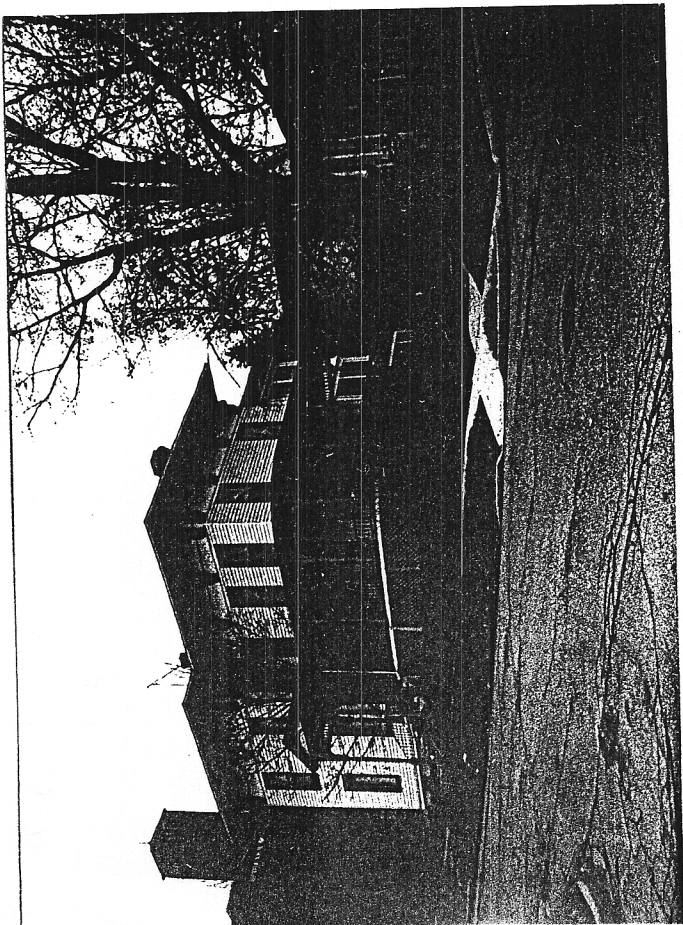
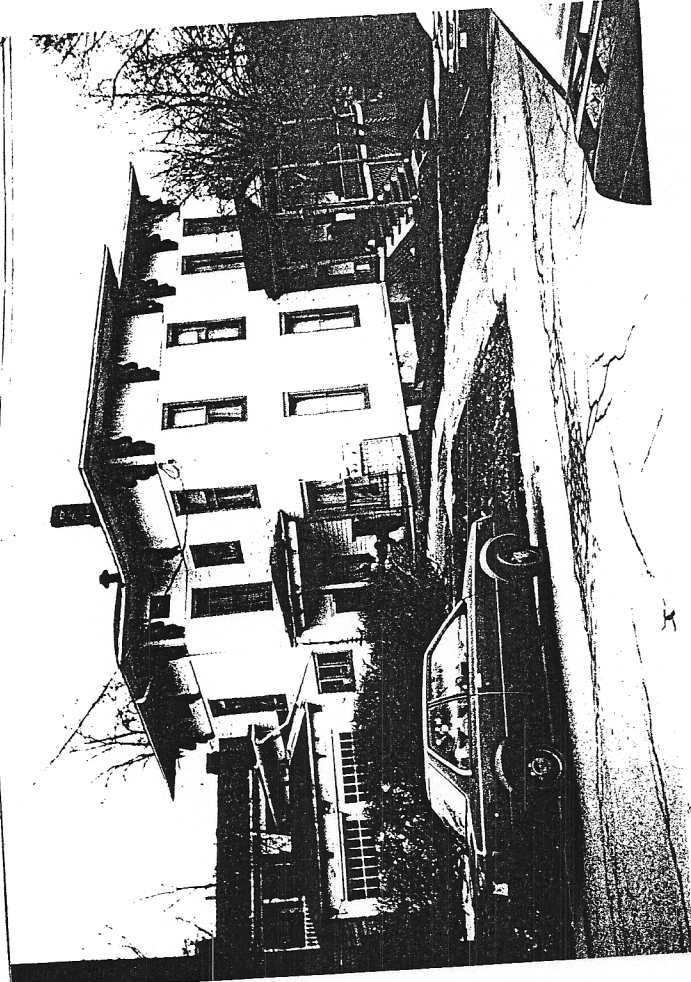
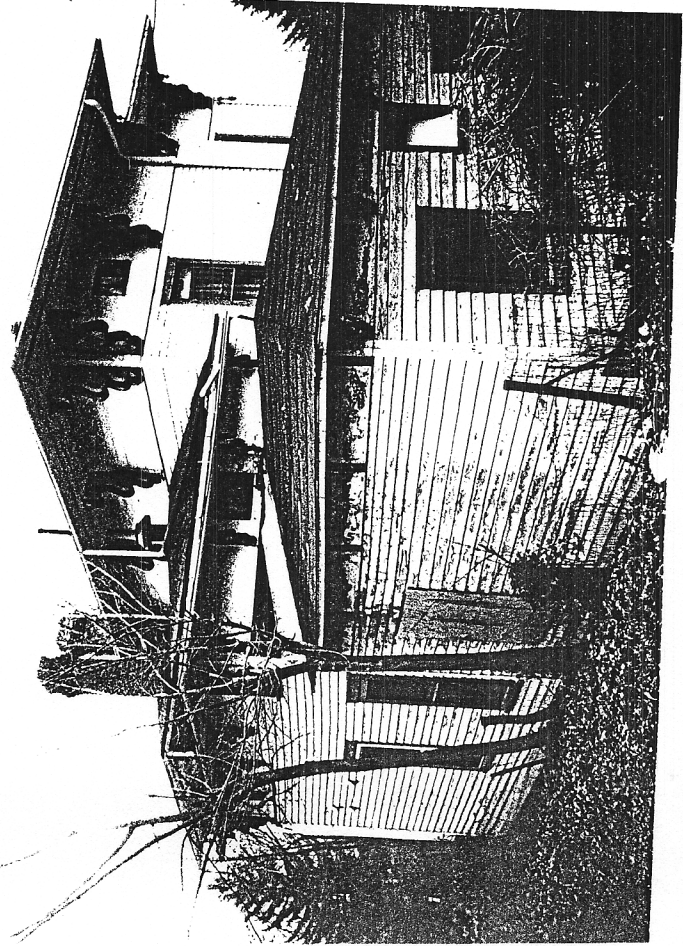
all - 177 Pine St.

177 Pine Street is a two-story residence which functions as a four unit apartment today. The home was built in the Italianate Style which was predominant in New York between 1840-80. According to McAlester's *Field Guide to American Houses*, the Italianate is characterized by a low pitched or flat roof with broad overhanging eaves supported by decorative brackets. Elongated, narrow windows are also commonly found on buildings of this style. Italianate buildings often possess asymmetrical plans with irregular massing as exemplified by 177 Pine Street.

The principal or north facade faces the park and is four bays wide. The windows are typically one-over-one double-hung sash and possess the elongated quality associated

with the Italianate. The roof line drops to accommodate the addition which was added between 1888-93. This portion of the facade is a single bay, defined by a projecting bay containing one-over-one sash on both stories. This bay is capped by a narrow pediment which is typical of Italianate crowns. Nevertheless, the shingle pattern between the first and second story evoke the Queen Anne Style and indicate this decorative embellishment may have occurred after 1880 when that style came into prominence.

The west facade is the most complicated as it contains the post-1888 additions. Here, the roof line is varied due to the two-story addition juxtaposed near the one-and-a-half story addition. While the northwest addition contains one-over-one sash, the southwest addition is characterized by six-over-six sash, uncommon to the Italianate. Also notable on this facade is the occurrence of hopper windows in the frieze band, irregularly spaced between the brackets. Because they do not occur in a particular pattern, they may have been added at a later date or may be hidden behind the vertical siding.

The south facade appears as irregular in massing as the west facade. Here, the rear barn indicated on the 1888 Sanborn was converted into a two car garage between 1930-1948 according to these same maps. The windows on this facade are typically one-over-one double-hung sash on the first and second story but also contain a band of three casement windows on the first story. The garage adopts the same stylistic features evident on the house as small brackets support the overhanging hipped roof. A band of eight-over-eight fixed windows are present on the double doors of the garage and provide an interesting contrast to the one-over-one sash windows found on the house.

The east facade is six bays long and is dominated by the verandah which sweeps around to the north facade. The principal entry to the house is gained through double leaf sash doors whose attenuated quality blends easily with the dominant fenestration type. The verandah itself possesses characteristics associated with the Folk Victorian or Eastlake designs. For example, a spindle frieze and turned brackets are joined to turned posts, unified by the turn baluster railing which wraps around the facade. In addition, the stoop is covered by a pedimented porch, supported by these same posts.

The feature most common to all facades are the voluptuous brackets which support the overhanging eaves of the hipped roof. Three interior chimneys are also included within the house. While two emerge from the principal mass of the house, the third occurs within the west facade of the addition. The chimneys closest to the northwest corner have corbeled caps as well. Although the house sits on a stone foundation, it has been covered with concrete on the west facade. Overall, the house is sheathed in a combination of wood clapboarding and horizontal and vertical aluminum siding in the frieze area between the brackets on the north and east facade. Flushboard siding occurs in the frieze on the south and west facades.
