BUILDING-STRUCTURE INVENTORY FORM
DIVISION FOR HISTORIC PRESERVATION
NEW YORK STATE PARKS AND RECREATION
(518) 474-0479

TOWN/CITY: Corning

3. STREET LOCATION: 178 Pine Street

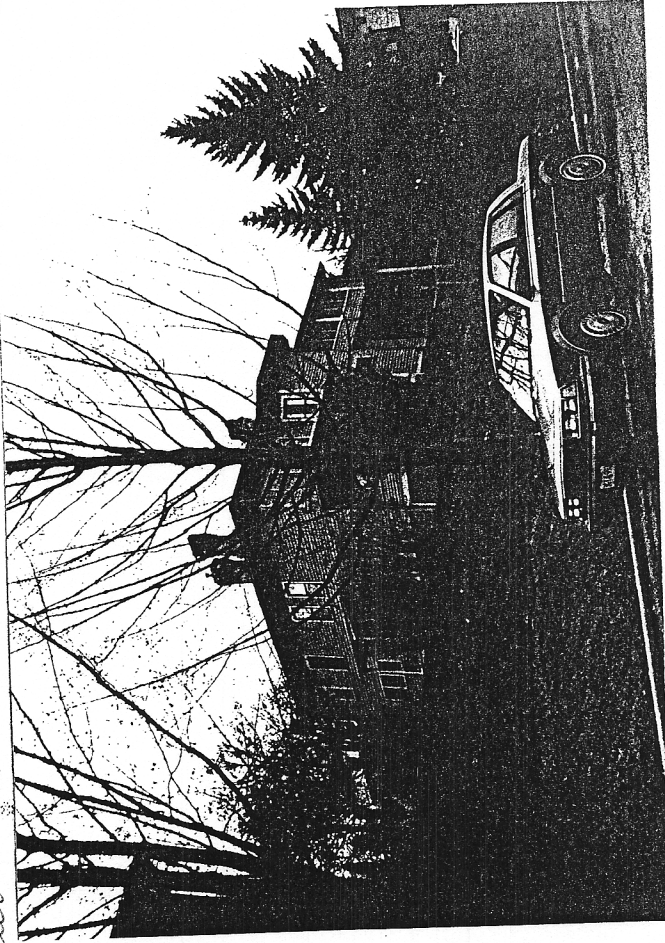
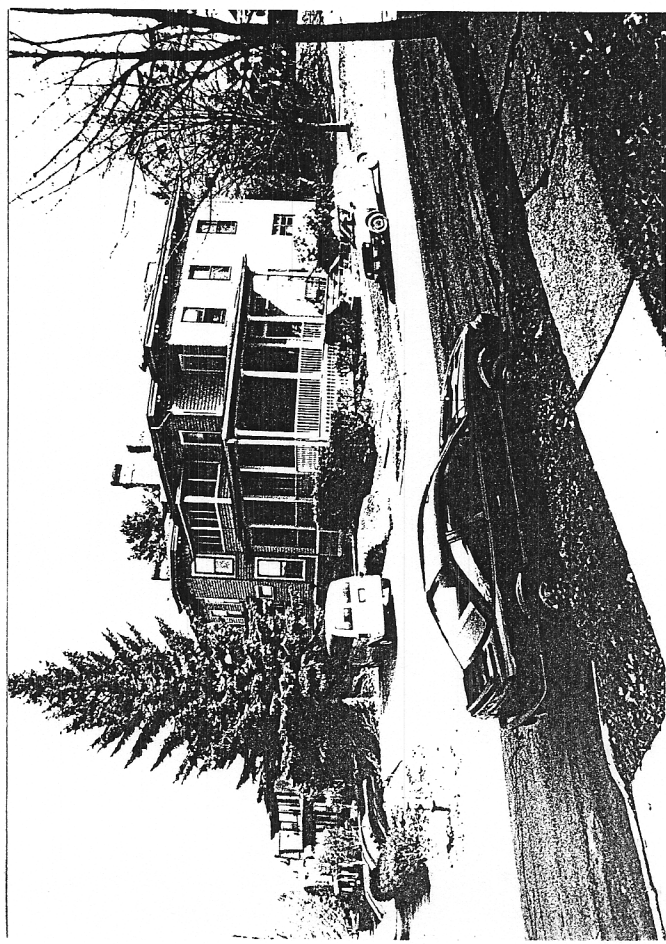
← 178 Pine Street →

The principal or north facade is six bays wide, defined by a fenestration pattern dominated by one-over-one double-hung sash windows. The west facade is three bays wide, punctuated by one-over-one double-hung sash. These windows are typical on the north facade while the south and east facades contain double-hung two-over-two sash as well. A verandah occurs in two stages, separated by the canted bay on the north facade. The first portion extends from the west to the north facade and was present as early as 1888, although the configuration which survives is not the one documented on the Sanborn map. Octagonal columns are evident here as is a balustrade consisting of turned balusters. East of the canted bay, a shed-roofed porch with a closed rail was appended after 1948 according to the Sanborn map. The most notable feature of the east facade is the band of casement windows on the first story distinguished by a three-over-one pattern, replicating itself six times to form a coherent decorative scheme. The most notable feature of the south facade is the hood placed over the window punctuating the rear vestibule, supported by brackets to either side. All four facades are embellished with paired brackets, supporting the broadly overhanging eaves associated with the Italianate Style. The frieze has incised geometrical ornamentation which visually unites it with the brackets.

While the structure is sheathed in wood clapboards, the roof is flat. Three interior chimneys occur and are most evident from the southeast corner of the property. Each

chimney is laid in a decorative pattern with corbeled caps. West of the canted bay, three shed dormers occur above the north, south and west facades. The house itself sits on a random-coursed ashlar masonry foundation. Furthermore, between 1893-1908, the Sanborn maps document the existence of an
