BUILDING-STRUCTURE INVENTORY FORM

ORGANIZATION (if any): Preservation Planning Workshop, Cornell University

CONTINUATION SHEET, Page 1
116 1/2 East Second Street
Corning, New York

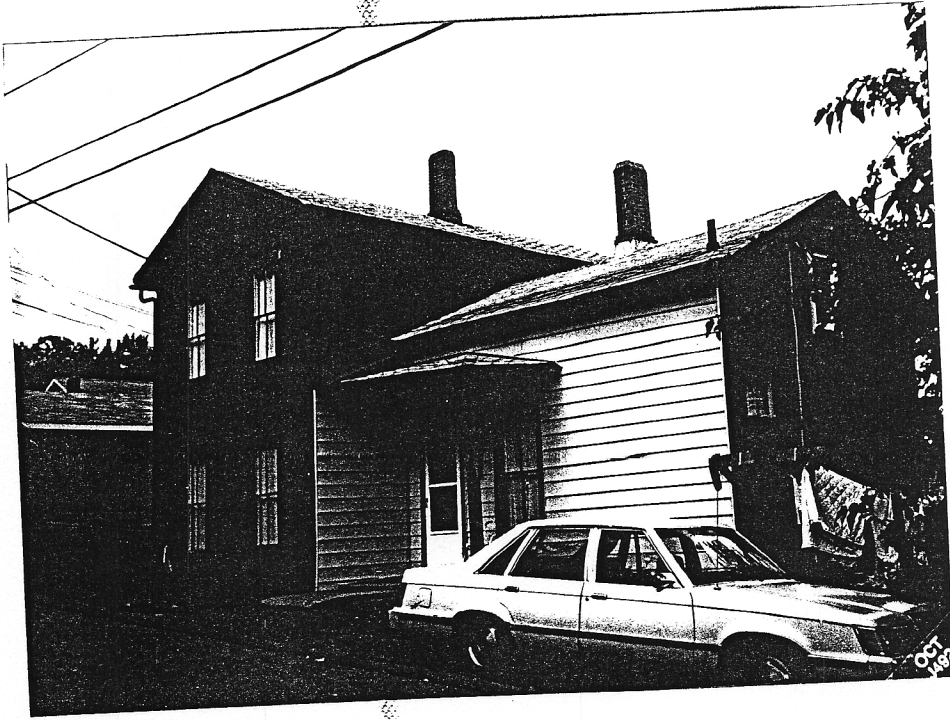
116 $\frac{1}{2}$ East 2nd

116 1/2 East Second Street is a one-and-a-half and two story structure with two intersecting gables. The main gable follows a north-south direction and is above the two-story part of the house. The porches on the north and south sides have shed roofs. All roofs are covered in asphalt and the main gable is pierced by a chimney. The majority of the exterior walls are covered in asphalt shingles, but the north wall of the one-and-a-half story area is covered with aluminum siding.

Almost all windows are two over two sash. Other sizes are present in the bay and on the east facade. No windows are present on the west facade. The south facade of the main area has a fenestration pattern of two bays. Two doors permit entry to the house and are located on the porches on the north and south sides. The shed roofs of the porch to the south is supported by a single, square pier.
