BUILDING-STRUCTURE INVENTORY FORM

YOUR NAME: Stephanie Reinert DATE: December 18, 1992
YOUR ADDRESS: 106 W. Sibley Hall TELEPHONE: (607) 255-6851
ORGANIZATION (if any): Preservation Planning Workshop, Cornell University

CONTINUATION SHEET, Page 1
120 East Second Street
Corning, New York

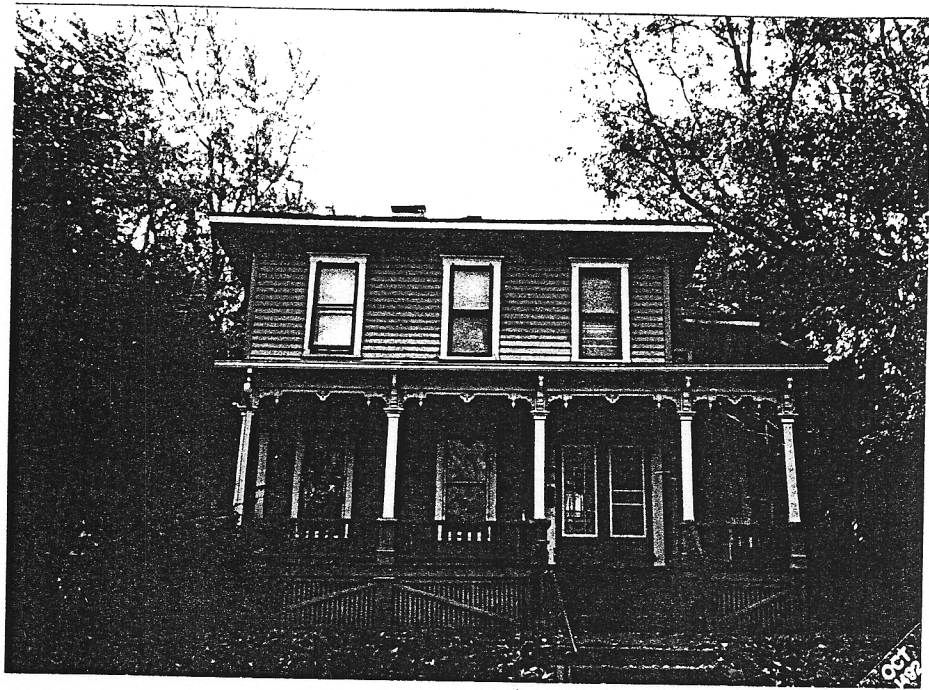
120 East 2nd

120 East Second Street is a two-story, rectangular dwelling, with a two-story bay on the west facade. The pyramidal and hipped roofs are covered in asphalt siding and pierced by two chimneys. The foundation is parged stone and the exterior walls are covered in clapboards. However, the bay is plastered. The house is slightly raised from the ground and probably has a basement.

The main facade, on the north, has a distinct three-bay fenestration, and the windows throughout the structure are two-light, awning type. The windows have simple surrounds which show only a hint of a cornice at the top sill. The main door, which faces Second Street, is a double door with lights. The surround of the door is detailed in a classical manner, with two consoles and an entablature. Another glazed door is located on the west

side, where the bay juts from the wall.

The wraparound porch on the north and west sides is the most decorative element of the structure. The porch roof is supported by six square piers, and is accentuated by brackets and dentils beneath the eaves. Dentils are also present beneath the eaves of the main roof. There is also a plainly-decorated banister and stairs which lead to the porch from the sidewalk.
