BUILDING-STRUCTURE INVENTORY FORM

- 1. BUILDING NAME(S):
- 2. COUNTY: Steuben TOWN/CITY: Coming VILLAGE:
- 3. STREET LOCATION: 136 East Second Street
- 4. OWNERSHIP: a. public [] b. private [X]
- 5. PRESENT OWNER: Kenneth J. & Paula S. Berkes ADDRESS: 136 East Second Street
- 6. USE: Original: Residence Present: Residence
- 7. ACCESSIBILITY TO PUBLIC: Exterior visible from public road: Yes [X] No []
Interior accessible: Yes [] No [X] Explain: Private residence

CONTINUATION SHEET, Page 1
136 East Second Street
Corning, New York

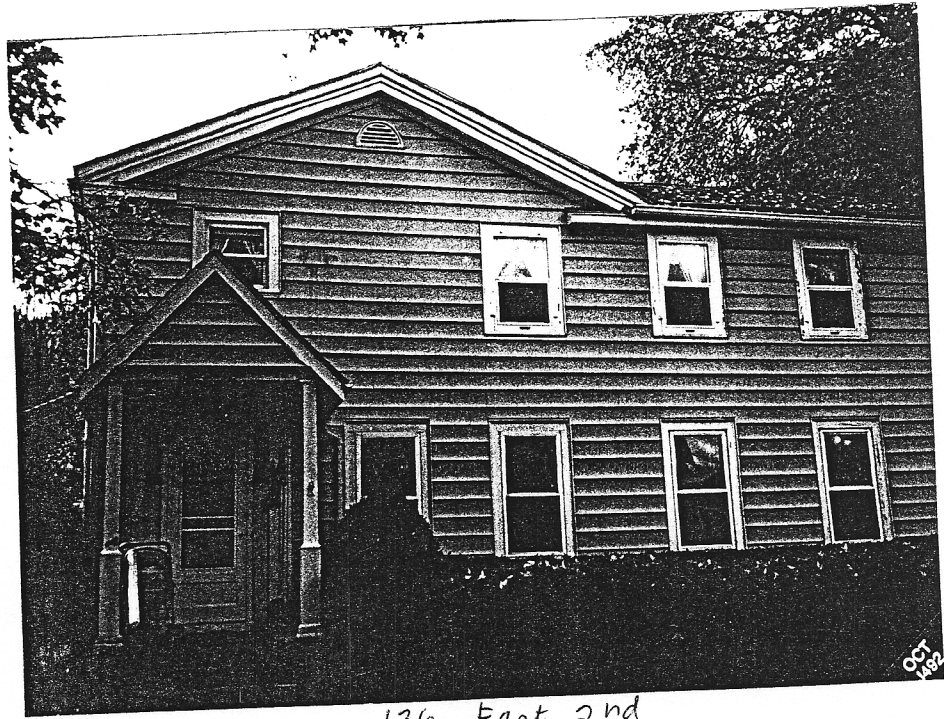
136 East 2nd

136 East Second Street is a two-story structure, with a gable that runs perpendicular to the street on the eastern half of the main body. This gable end has returns, as do the others. The house has a parged foundation and the exterior walls are covered in aluminum siding. The roofs are covered in asphalt and there is one chimney which pierces it.

A single-story entry porch is located on the northeast corner of the structure. The small gable roof is supported by two square piers. This porch rests on a stone foundation that incorporates steps into the form.

The fenestration pattern of the main, north facade includes five bays. All windows are two-light awning and have similar proportions. However, the windows on the second floor are slightly shorter than those on the first floor. A small window is present above the roof of the entry porch, and a semi-circular vent is located in the gable end. The front doorway includes a glazed, single door with sidelights that have been partially covered.
