CONTINUATION SHEET, Page 1
138-142 East Second Street
Corning, New York

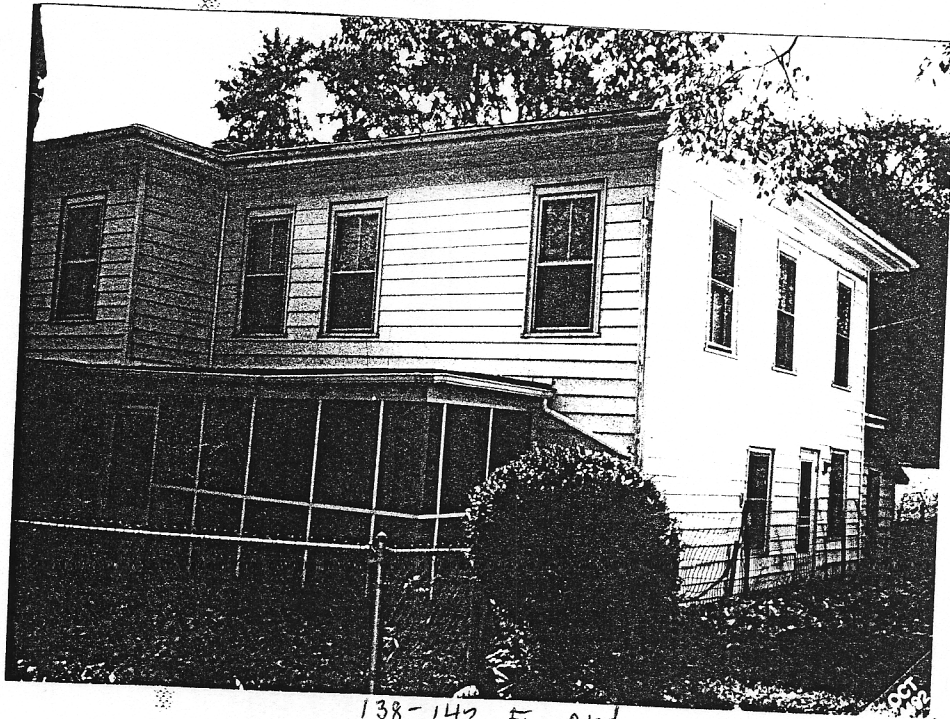
138-142 E. 2nd

138-142 East Second Street is comprised of two dwellings, attached by one wall. They are each rectangular structures and have hipped roofs. Both dwellings each also have two, one story additions to the south. The exterior walls of the building are covered with aluminum siding and the roof has asphalt shingles. There are also two chimneys, but the foundation is not visible.

142 has a three-bay fenestration pattern in the second floor, while 138 has three windows, but is asymmetrical. All windows on the main facade are of the same size and two over-two sash. Most other windows in the building are of a similar size. The main doors are within the porches on the north facade.

Both dwellings also have full, one-story porches on the north facade. These porches are screened, have flat roofs, and are supported by iron posts.
