BUILDING-STRUCTURE INVENTORY FORM

ORGANIZATION (if any): Preservation Planning Workshop, Cornell University

Continuation Sheet, Page 1
66 East Second Street
Corning, New York

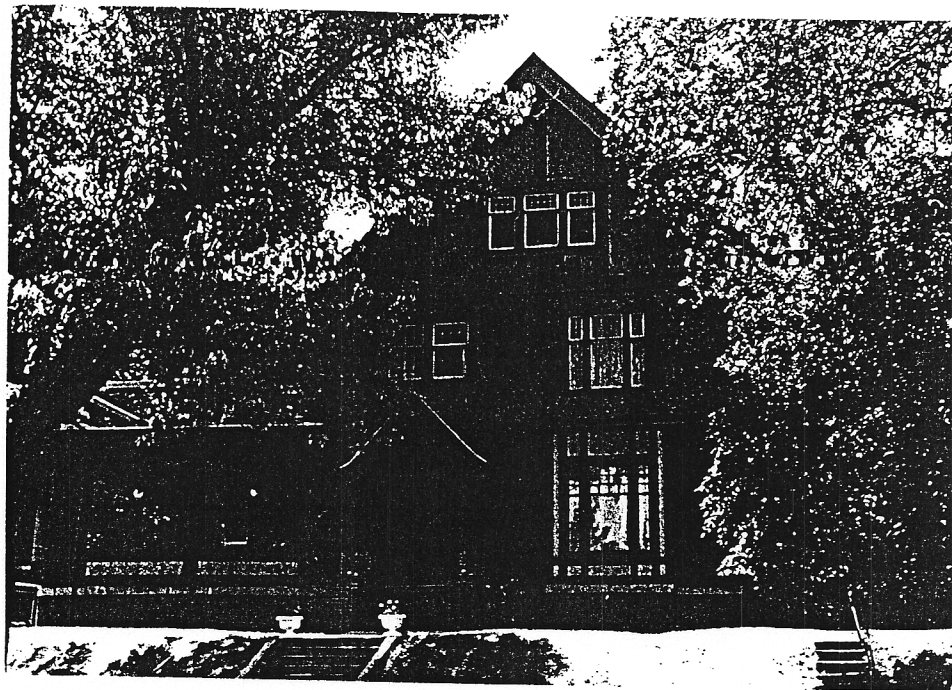
66 E. 2nd

This hipped-roof Tudor Revival ^{style} house features a projecting front-gable bay, with a cross gable on the western facade. This wood-framed house has a brick veneer on the first story, with an overhanging second story covered in stucco. Exposed ^{half-timbering} joists accent the projecting story and ~~are~~ ^{are} continued ^{across} the cornice line of the porch in a slightly more elaborate form. The body of the house

has a cast stone foundation with a simple stone water table separating the foundation from the brick-clad portion of the wall. Another Tudor Revival style decorative element is the large chimney on the western facade of the house. The tower portion has the same water table as the main part of the house, but also has stone chimney wings just above the first story. This chimney is constructed of over-sized bricks. There are also two more utilitarian chimneys, one at the rear of the house and another in the main block.

The gable roof on the front-gable and cross-gable areas overhang the gable ends and are finished with a wide bargeboard. A gable dormer on the eastern side facade of the main block also has a roof which projects well over the body of the dormer.

This form is echoed in the small flared gable which is inserted in the cutaway section of the porch in front of the main entrance. Heavy wooden brackets help support this gable. Decorative half-timbering is present on all of the gables, and also appears on a stuccoed three-part window bay on the front facade. The closed railings on the front porch are stuccoed as well.

Brick piers constructed with oversized textured bricks support the flat roofed porch, while the foundation of the porch is made of more typically-sized bricks with structural vent openings. Smaller wooden supports help support the wide spans between the brick piers, providing additional structural security to the second-story deck above the porch. A temporary wooden rail rail has been installed on the upper level. The ceiling of the porch is made of thin wooden strips which form a mitered joint at the corner.

The windows on this house are generally double-hung sash, with a few casement windows on the secondary facades. The double-hung sash on the front facade are grouped together, with three-part window bays on both the first and second-story levels. These windows are more similar to those found on Prairie Style homes than to the multiple light windows commonly associated with the typical Tudor Revival Style structure. There are several different light configurations, including fifteen-over-one, ten-over-one, eight-over-one, and ten-over-one sash. Some of the windows at the first floor level have stone lug sills which match the water table.
