# BUILDING-STRUCTURE INVENTORY FORM

YOUR NAME: Lisa Adkins  
YOUR ADDRESS: 106 W. Sibley Hall  
ORGANIZATION (if any): Preservation Planning Workshop, Cornell University

- 1. BUILDING NAME(S):
- 2. COUNTY: Steuben TOWN/CITY: Coming VILLAGE:
- 3. STREET LOCATION: 70-72 East Second Street
- 4. OWNERSHIP: a. public [ ] b. private [X]
- 5. PRESENT OWNER: Robert Johnson ADDRESS: [Redacted] Present: ~~two~~ Multiple <sup>units</sup> apartmentse
- 6. USE: Original: ~~Single~~ family residence
- 7. ACCESSIBILITY TO PUBLIC: Exterior visible from public road: Yes [X] No [ ]  
Interior accessible: Yes [ ] No [X] Explain: private residences

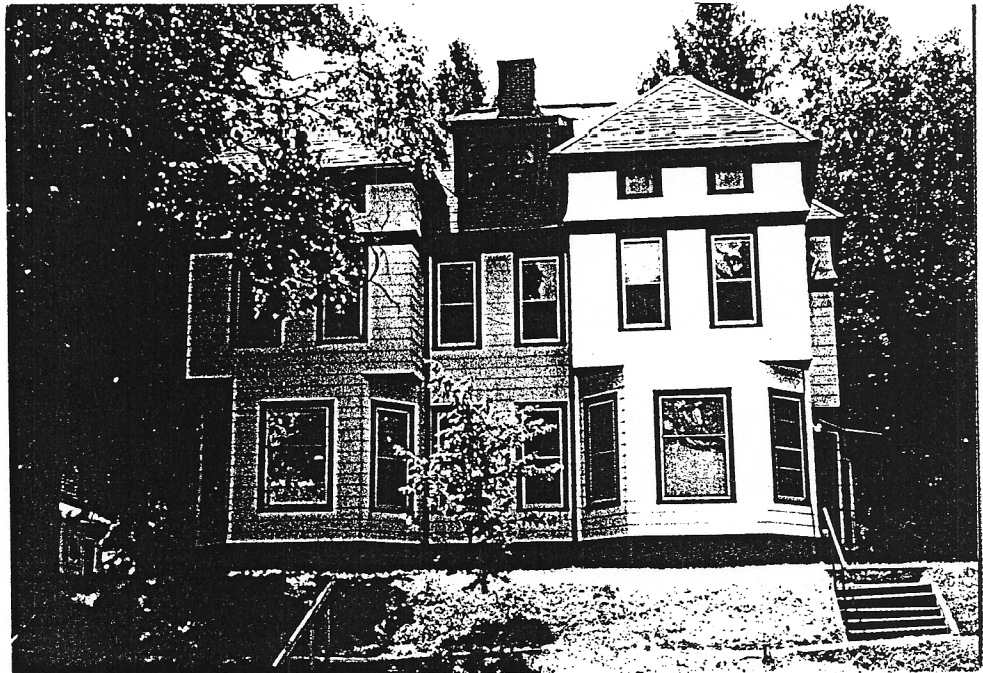
70-72 E. 2nd

This two-family residence was constructed ca. 1905-07. The only <sup>alteration</sup> addition has been <sup>an addition creating</sup> that of a second-story level to the rear section of the building. A pair of wraparound front porches on either end of the front facade were removed and replaced with concrete stoops in 1967. *And siding?*

The shape of the building is symmetrical with matching hipped cross gables on the front of the structure and on each side. There are also matching ~~three-part~~ windows bays on each side facade. <sup>windows</sup> The three-part clipped bays on the front (north?) facade have one-over-one double-hung cottage sash in the central portion of the bays. The rest of the house Generally has standard-sized one-over-one double-hung sash. There is one shed dormer on the front facade which has four-over-one sash.
