# BUILDING-STRUCTURE INVENTORY FORM

- 1. BUILDING NAME(S):
- 2. COUNTY: Steuben TOWN/CITY: Corning VILLAGE:
- 3. STREET LOCATION: 76-78 East Second Street
- 4. OWNERSHIP: a. public [ ] b. private [X]
- 5. PRESENT OWNER: John Hufnagel ADDRESS: ?
- 6. USE: Original: ~~Single~~ family residence Present: Multiple <sup>units</sup> apartments (4)
- 7. ACCESSIBILITY TO PUBLIC: Exterior visible from public road: Yes [X] No [ ]  
Interior accessible: Yes [ ] No [X] Explain: private residence

Continuation Sheet, Page 1  
76-78 East Second Street  
Corning, New York

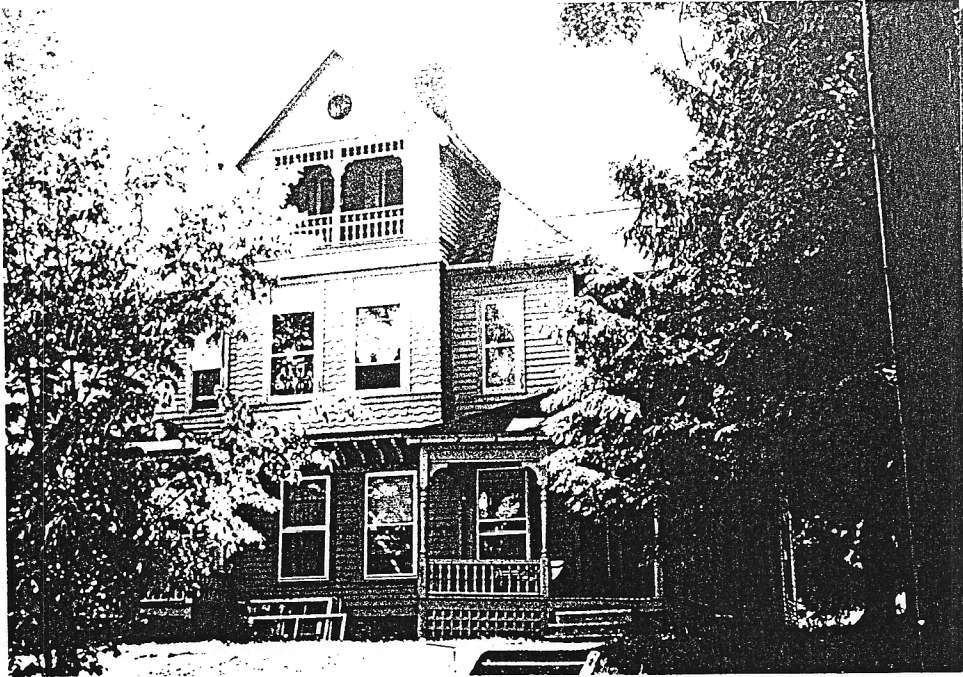
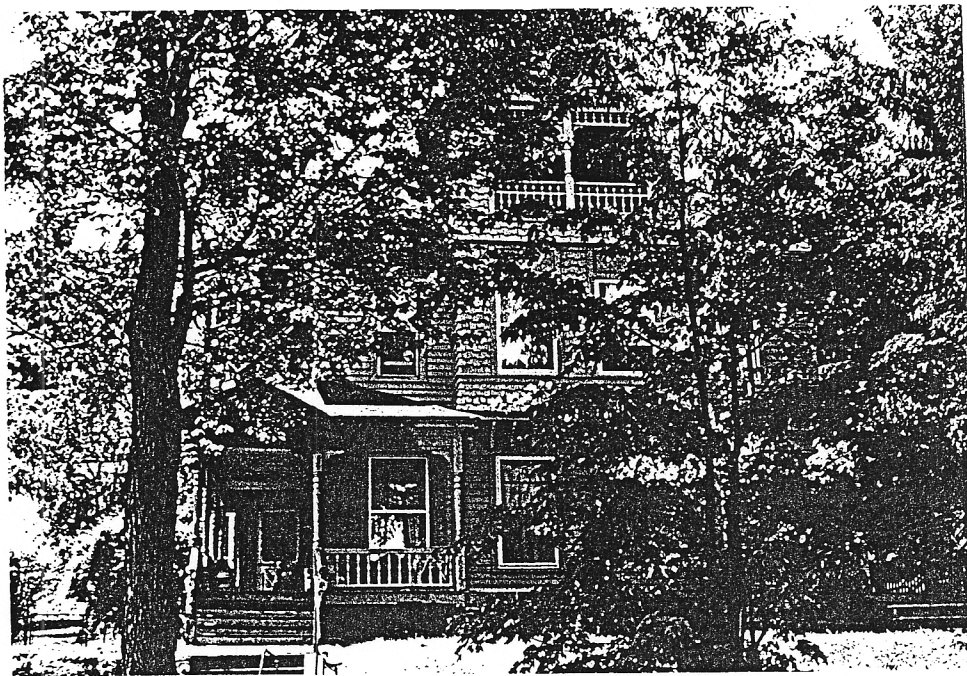
76-78 E. 2nd

The two-family residence at 76-78 East Second Street <sup>or (4) ?</sup> is a fairly symmetrical building that manages to appear asymmetrical by the clever use of contrasting building materials and juxtaposed roof planes. The foundation is made of partially parged fieldstone <sup>which</sup> but <sup>while</sup> the rest of the building is clad in clapboard and wood shingles. The roof is covered in diamond-patterned asphalt shingles, with a brick chimney set at the roof's peak. <sup>the photos don't make it look asymmetrical</sup>

The two-and-a-half-story building has a hipped roof with a large front wall dormer. There is a decorative <sup>recessed balcony</sup> inset porch with a spindlework frieze and balustrade centrally placed at the peak of the front facade. <sup>(north?)</sup> The overhanging ~~section~~ section of the front wall dormer has coarsed wave-edged wood shingles, and is visually supported by a series of large brackets. The vergeboard of this dormer is <sup>I think this is a REAL name for these...</sup> further decorated with a cross-hatched design accented with a bull's-eye motif.

Two full-height tower-like bays are set on the east and west facades, just behind a pair of wraparound porches that are decorated with turned spindlework balustrades with solid brackets and cutwork skirts. The modern entrance doors face the street, but are set on the secondary facades. The windows on the building are generally one-over-one double-

hung sash, but there are some small multi-colored <sup>Queen Anne</sup> ~~fifteen-over-one~~ sash in the eastern bay and a circular window in the front wall dormer.  
spelling?
