BUILDING-STRUCTURE INVENTORY FORM
DIVISION FOR HISTORIC PRESERVATION
NEW YORK STATE PARKS AND RECREATION
ALBANY, NEW YORK (518) 474-0479

1. BUILDING NAME(S):
2. COUNTY: Steuben TOWN/CITY: Corning VILLAGE:
3. STREET LOCATION: 23 West Sixth Street
4. OWNERSHIP: a. public [] b. private [X]
5. PRESENT OWNER: Gerald J. Fine and Victoria L. Lefevre
ADDRESS: Same as above
6. USE: Original: Private Residence Present: Private Residence
7. ACCESSIBILITY TO PUBLIC: Exterior visible from public road Yes[X] No []
Interior accessible: Yes [] No [X] Explain:

19. DATE OF INITIAL CONSTRUCTION: 1908
ARCHITECT:

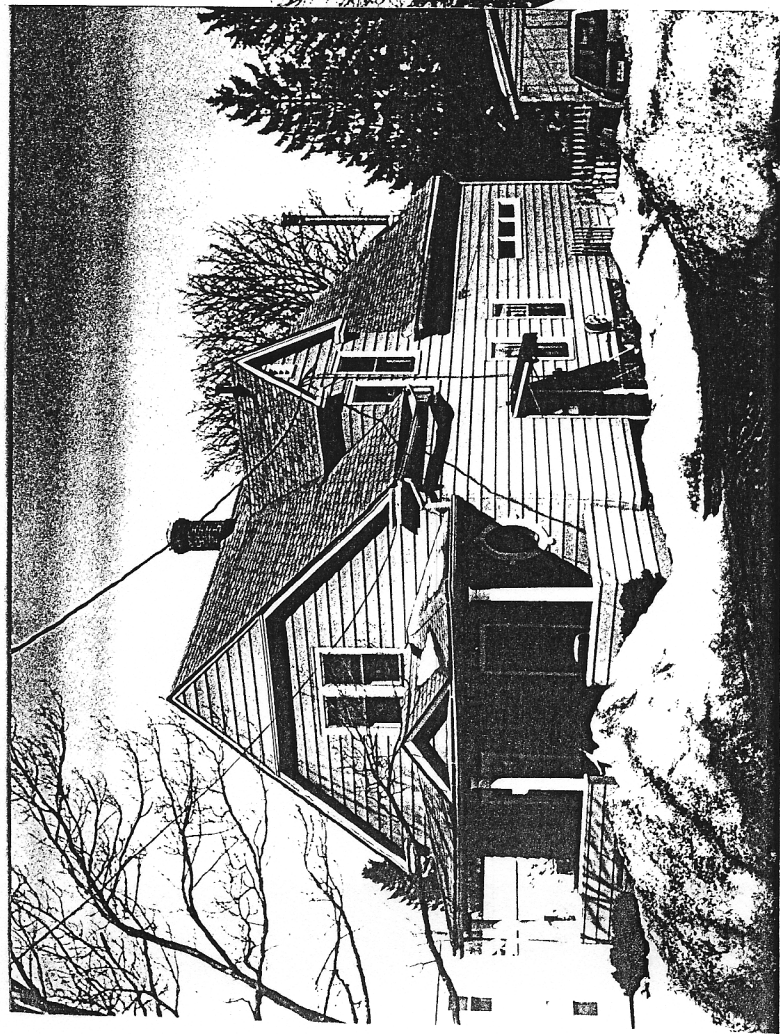
~ 23 West 6th → outbuilding

There is a garage to the immediate north-east of the house, bordering the east boundary of the lot. A three foot wire fence encompassing the entire lot north of the house was removed in 1991.

The house is constructed with aluminum siding, with an asphalt roof. The house rests on a coursed stone foundation. There is a two-car garage at the north-east corner of the lot, with aluminum siding and a low pitched gable roof.

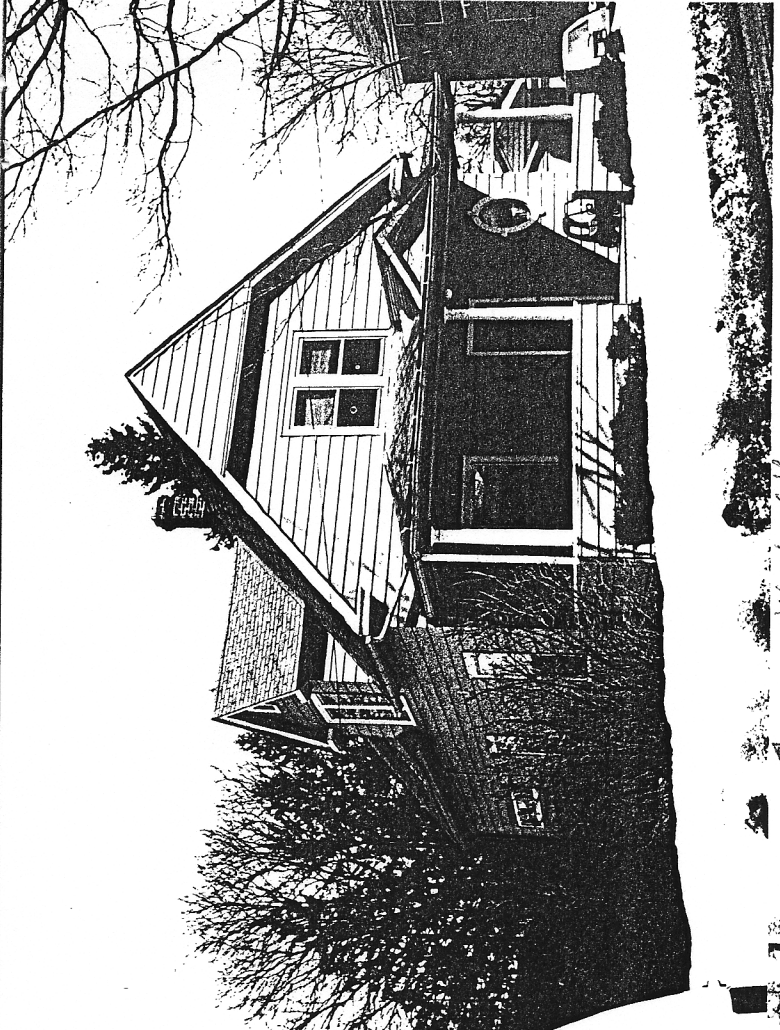
~ 23 West 6th

The front (south) facade features a one-story full-width porch with a hipped roof with a pediment at the entry steps. The porch has an enclosed railing with Doric columns. The front entrance is off-center and an oval window is set between the entry door and the southeast corner. A large cottage-style window dominates the rest of the first-story level of this facade. Paired one-over-one double-hung sash are centered in the gable end of the south facade at the second story level, beneath a closed pediment which occupies the peak of the gable end.

Pedimented wall dormers are the prominent stylistic feature of the east and west facades. The west wall dormer has paired double-hung sash, while the dormer has two separate, stepped double-hung windows. The east facade also has a first-story entrance, sheltered by an awning hood. The remainder of the first floor are one-over-one double-hung sash, with the exception of a string of three small replacement windows which have been inserted in the northernmost bay of the east and west facades. The north facade features an entrance with sliding glass panes centered on the first floor, with two double-hung cottage windows arranged symmetrically in the gable end on the second story.
