BUILDING-STRUCTURE INVENTORY FORM

3. STREET LOCATION: 24 West Sixth Street

CONTINUATION SHEET, Page 1 24 West Sixth Street Corning, New York

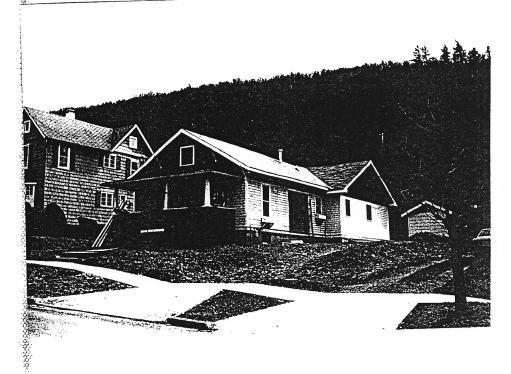
V 24 West 6th

The main entrance, facing north, is situated beneath the porch, which has three battered piers atop an enclosed railing supporting a flat roof. The entrance door, with three panels, is flanked by one-over double-hung windows. There is a single fixed window centered in the gable end. There are stick brackets visible beneath the eaves of the gable roof. The east facade has a multipaned sash near the northeast corner, and cottage-style windows on the projecting gable wall. The west facade has a one-over-one double-hung window near the northeast corner, and two repacement windows on the projecting gable wall. On the south facade there are two one-over one double-hung windows near the southwest corner a one-over-one double-hung cottage-style window placed slightly off-center toward the southeast corner.

The house is clad on the first story level with clapboard, with texture 1-11 siding on the half-story above. The foundation of the house is of poured concrete, excepting the rear addition (see 11c) which has a concrete block foundation. The structure has an asphalt roof. There is a small shed at the southwest corner of the lot, clad with vinyl siding with an asphalt roof.
