BUILDING-STRUCTURE INVENTORY FORM
DIVISION FOR HISTORIC PRESERVATION
NEW YORK STATE PARKS AND RECREATION
ALBANY, NEW YORK (518) 474-0479

YOUR NAME: Azhar S. Tyabji
YOUR ADDRESS: 106 W. Sibley Hall, Ithaca, NY
ORGANIZATION (if any): Cornell University

1. BUILDING NAME(S):
2. COUNTY: Steuben TOWN/CITY: Corning VILLAGE:
3. STREET LOCATION: 30 West Sixth Street
4. OWNERSHIP: a. public [] b. private [X]
5. PRESENT OWNER: Clark M. and Marilyn C. Maloney ADDRESS: Same as above
6. USE: Original: Present:
7. ACCESSIBILITY TO PUBLIC: Exterior visible from public road Yes[X] No []
Interior accessible: Yes [] No [X] Explain: Private Residence

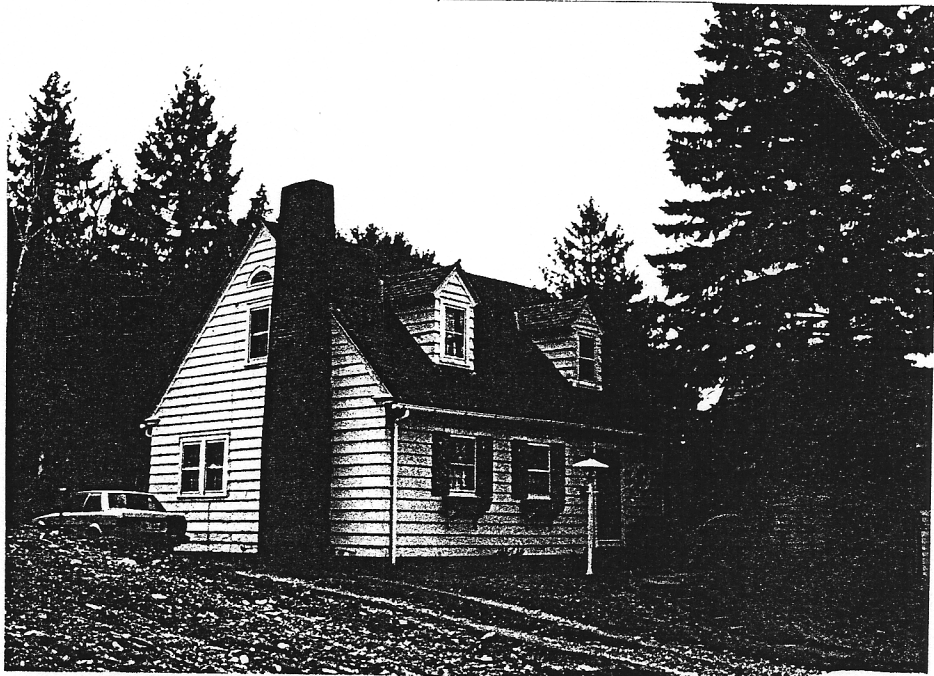
↙ 30 West 6th

This one-and-a-half story house at 30 West Sixth Street is a good example of a Cape Cod Gabled Cottage, as described in Gottfried and Jennings' American Vernacular Design, 1870-1940. The house follows stylistic convention quite closely, particularly in its use of a steeply pitched roof with low eaves over the facades, twin gable dormers, six-over-one double-hung sash, and an entrance with stoop.

The main (north) facade has an entrance with a stoop placed off-center, toward the northwest corner. There is an oval window with a stained glass motif between the entrance and the northwest corner. Between the entrance and the northeast corner, there are two one-over-one double-hung cottage windows. The main facade is accentuated by twin gable dormers projecting from the roof, each with a one-over-one double-hung cottage window. The east and west facades are similar in fenestration; there are two pairs of six-over-four double-hung sash on the first story (one pair on the east facade), and a single six-over-four double-hung sash centered in the the gable end and crowned with a fanlight. On the east facade, there is a brick chimney placed off-center, toward the northeast corner.

The south facade is dominated by a one-story projecting bay with a shed roof, covering the western three quarters of the facade. There is a bay window on the south facade of the projecting room itself, with two one-over-one double-hung sash on its east facade. The rest of the south facade has paired six-over-six double-hung sash in the reentrant angle formed by the projecting

bay, and two cottage-style fixed sags toward the southeastern corner. There are paired gable dormers on the roof, each with a six-over-six double-hung window.

The house is clad in clapboard siding, and has a coursed stone foundation. The roofing of the house is of asphalt.
