BUILDING-STRUCTURE INVENTORY FORM

- 1. BUILDING NAME(S):
- 2. COUNTY: Steuben TOWN/CITY: Corning VILLAGE:
- 3. STREET LOCATION: 5 West Sixth Street
- 4. OWNERSHIP: a. public [] b. private [X]
- 5. PRESENT OWNER: Michael S. Toro ADDRESS: 3 South Road
- 6. USE: Original: Private residence Present: Private residence
- 7. ACCESSIBILITY TO PUBLIC: Exterior visible from public road Yes[X] No []
Interior accessible: Yes [] No [X] Explain: Private Residence

19. DATE OF INITIAL CONSTRUCTION: 1927

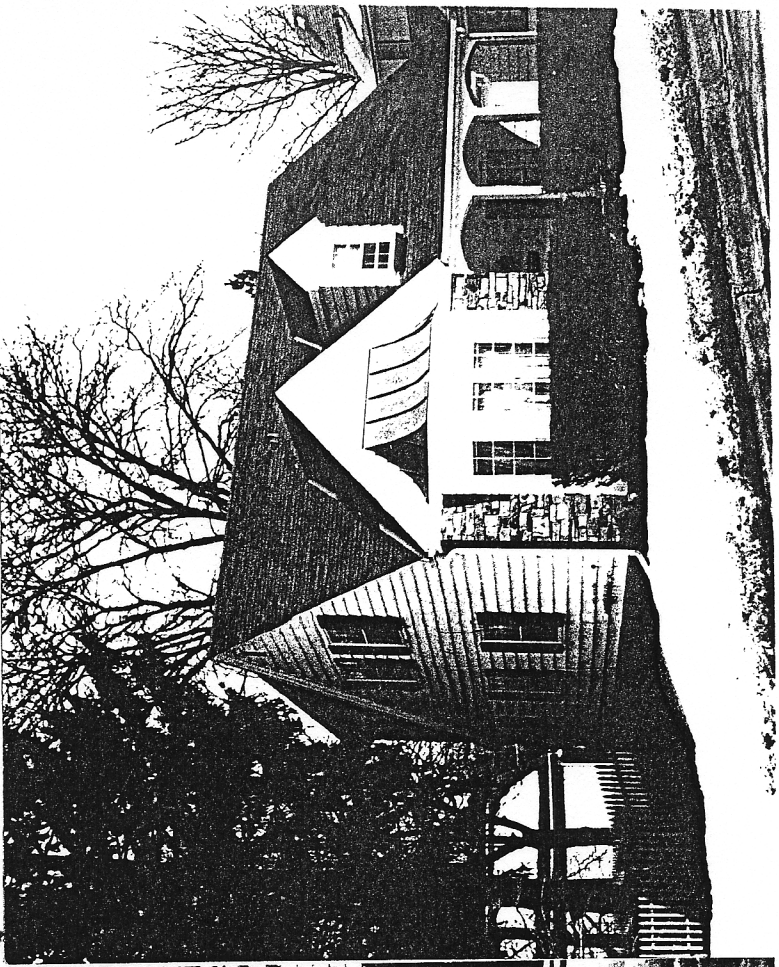
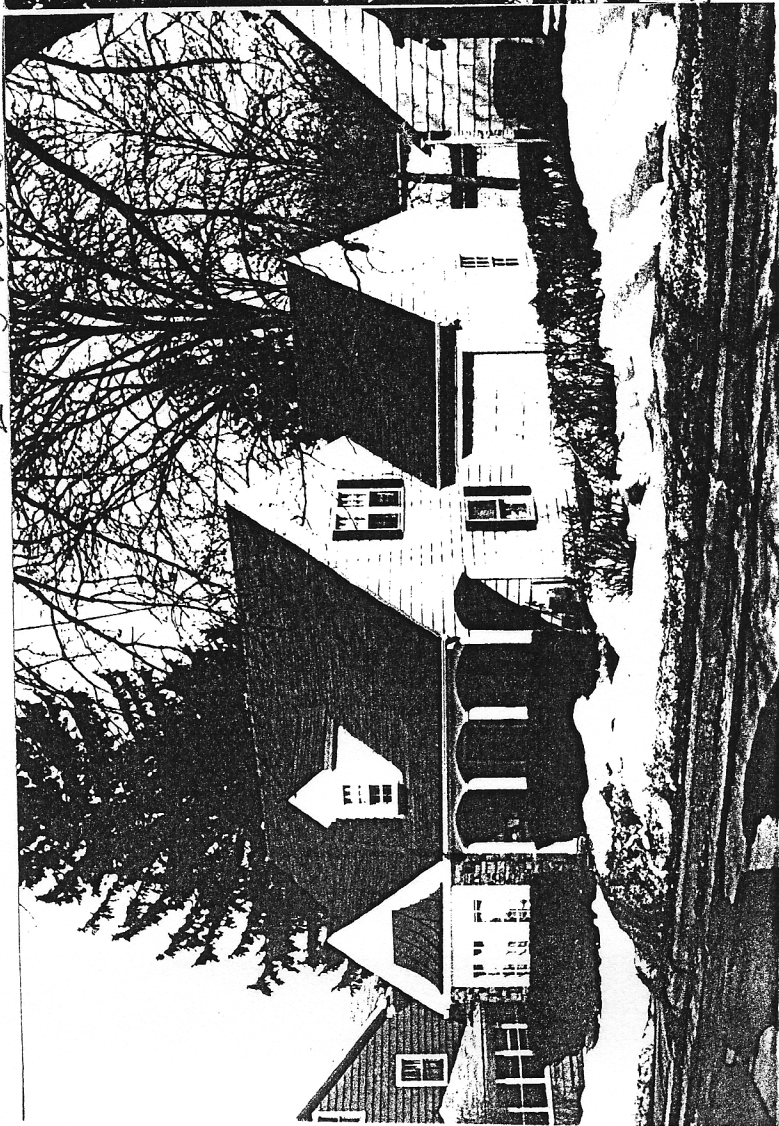
A 5 West 6th

The south (main) facade is dominated by a gabled wall dormer covering the western half of the facade. The first story level of the gabled wall dormer has an uncoursed stone veneer. On the first story level of the gabled wall dormer, projecting bay windows are set on canted walls beneath a flaired hip roof. The windows are casement sash with eight lights. The gable end has aluminum siding. The eastern half of the facade, adjacent to the gabled wall dormer, has a cutaway porch supported by square wooden posts set beneath shallow arches. The entrance is placed beneath the porch, and is centered on the facade. There is a six-over-six double-hung sash between the entrance and the southeast corner. Centered in the gable on the facade, and adjacent to the gable roof of the wall dormer, there is a gabled dormer with a six-over-six double-hung sash.
