BUILDING-STRUCTURE INVENTORY FORM
DIVISION FOR HISTORIC PRESERVATION
NEW YORK STATE PARKS AND RECREATION
ALBANY, NEW YORK (518) 474-0479

CONTINUATION SHEET, Page 1
75 West Sixth Street
Corning, New York

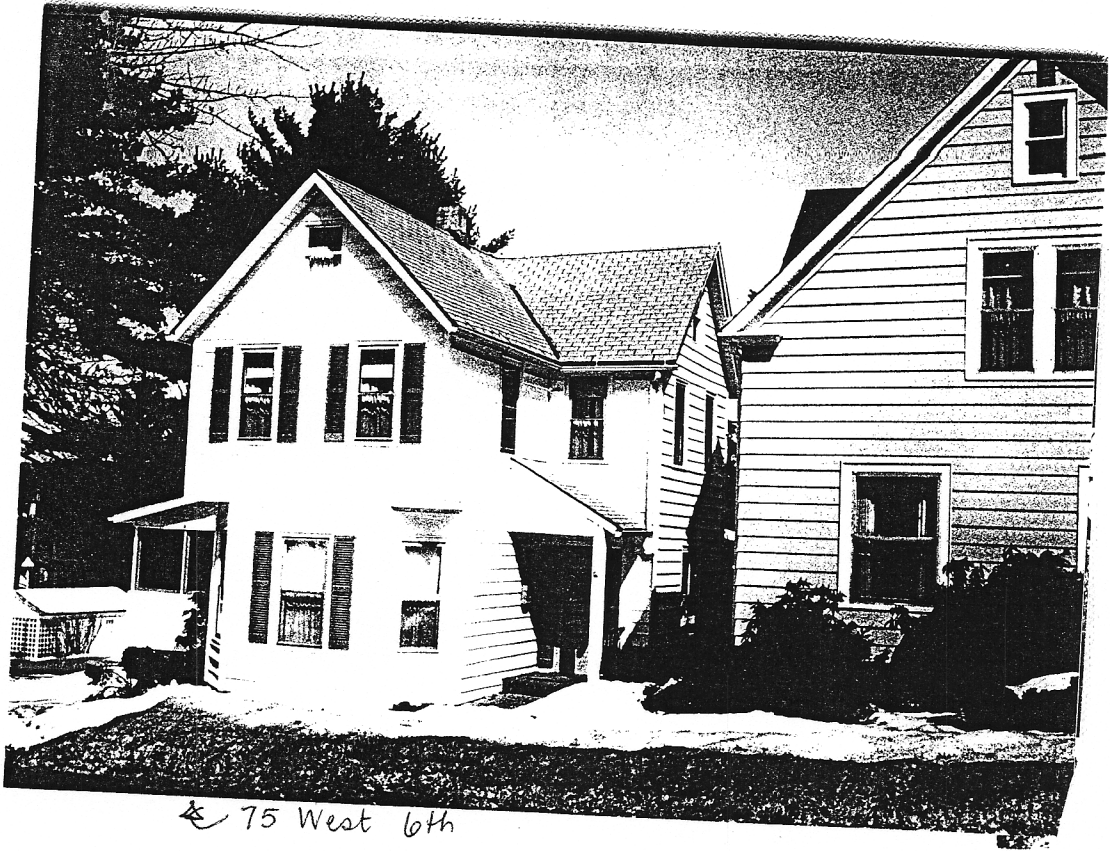
75 West 6th

This house, a two-and-a-half-story structure, is an example of the Gabled-Ell Cottage described in Gottfried & Jennings, American Vernacular Design 1870-1940, particularly in its use of symmetrical fenestration, a cutaway porch emerging from the ell, and canted walls.

The entrance to this house is accessed via a porch situated in the southeast reentrant angle. This door is sheltered by a shed roof supported by a single square pier and railing. On the south (main) facade of the house is a projecting gable wall with bay windows set within canted walls. The second story of the south gable wall consists of two one-over-one double-hung shuttered sash beneath a small double-hung sash centered in the gable end. The same pattern of fenestration is evident on the east gable end, while the asymmetry in fenestration on the west gable end is perhaps a consequence, in part, of the construction of a one-story family room with a low pitched roof, a skirt of latticework, and wrap-around glazed windows. On the second story of the west gable wall
