BUILDING-STRUCTURE INVENTORY FORM

- 1. BUILDING NAME(S):
- 2. COUNTY: Steuben TOWN/CITY: Corning VILLAGE:
- 3. STREET LOCATION: 175 East Third Street
- 4. OWNERSHIP: a. public [] b. private [X]
- 5. PRESENT OWNER: Ronald and Rosemary Kitson ADDRESS: 175 East Third Street
Present: residence
- 6. USE: Original: residence Present: residence
- 7. ACCESSIBILITY TO PUBLIC: Exterior visible from public road: Yes [X] No []
Interior accessible: Yes [] No [X] Explain: private residence

Continuation Sheet, Page 1
175 East Third Street
Corning, New York

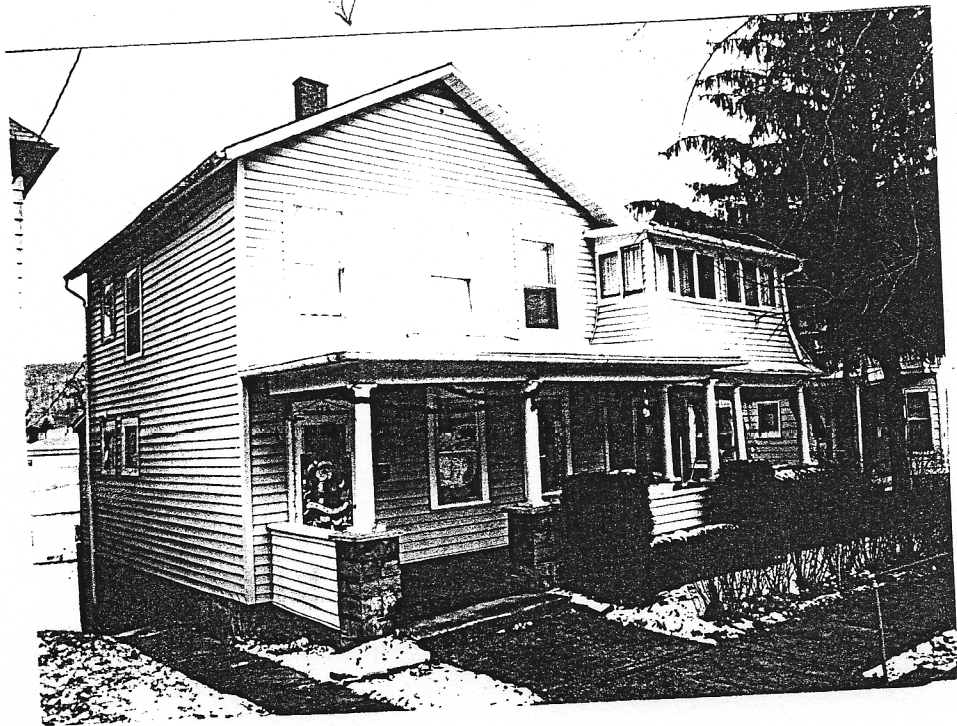
175 East 3rd

This house at 175 East Third appears to be of the Greek Revival Style with a gable end with as its principal facade and a lower side wing. This form is particularly common in New York. The principal block is three ranked with a doorway in the western most bay. The door surround is unusually simple for the style. Classical columns which sit on either brick piers or the enclosed balustrade support the porch which extends across the full length of the front facade. Classical columns are particularly common as a Greek Revival feature. Although many features leads one to believe the house was built in the Greek Revival style, certain features aren't Greek Revival. For example, rather than having the common six-over-six sash of Greek Revival houses, this house appears to have Italianate one-over-one sash. It is also missing the important characteristic cornice returns on the front gable end. These elements lead one to believe that the existing appearance is a result of the transitional period between the Greek Revival and Italianate periods or rather that when the vinyl siding was added the elaborate cornice and returns were removed or covered over.
