**BUILDING-STRUCTURE INVENTORY FORM**

- 1. BUILDING NAME(S):
- 2. COUNTY: Steuben                      TOWN/CITY: Coming                      VILLAGE:
- 3. STREET LOCATION: 40 East 3rd St.
- 4. OWNERSHIP: a. public [ ]    b. private [ x ]
- 5. PRESENT OWNER: Raymond F. Leinen                      ADDRESS: 40 East 3rd St.
- 6. USE: Original: Residential                      Present: Residential
- 7. ACCESSIBILITY TO PUBLIC:                      Exterior visible from public road: Yes [ x ] No [ ]  
Interior accessible: Yes [ ] No [ x ] Explain: private residence

Continuation Sheet, Page 1  
40 East Third Street  
Corning, New York

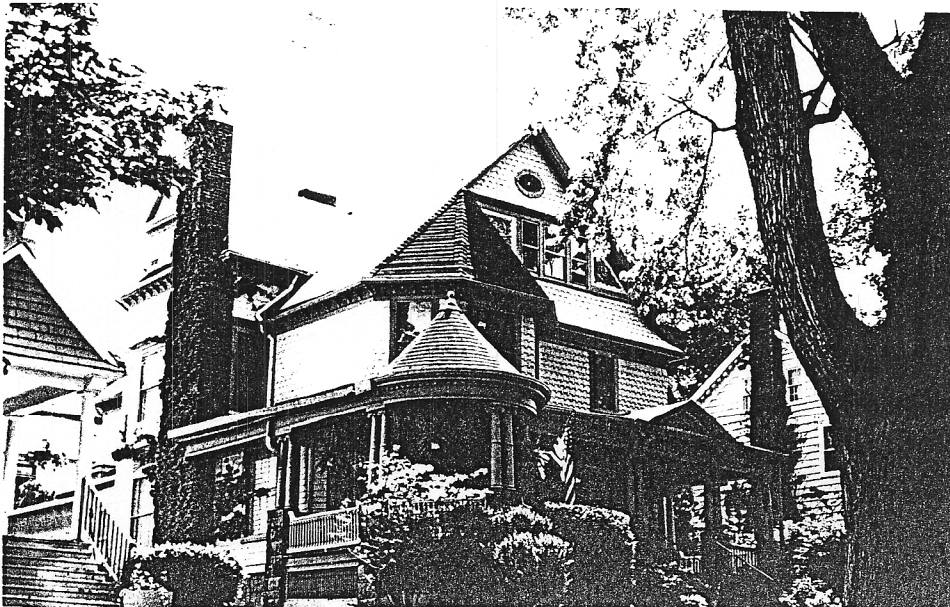
12. PHOTO:

This Queen Anne Style house has a gable front plan with a cross gable bay and dormer section on the eastern side. The house demonstrates the attributes of the Free Classic subtype of that style, in particular by the use of classically inspired columns and decorative detailing. The foundation of the house is irregularly coursed fieldstone covered in a cementitious material, and is scored to resemble randomly coursed blocks. The house is clad in staggered wood shingles on the upper story and gable ends, and has clapboard siding on the lower story. The front gable end is flared out from the plane of the wall, as is the upper part of the cross gable bay. The bottom shingle course both on the gable end and the rest of the house is finished with a decorative edging. A second-story tent-roofed tower section is cantilevered onto the front facade. There are regularly spaced brackets along the entire cornice line which serve to visually integrate the tower into the rest of the house.

The most distinctive feature of this house is the front porch. Its form is irregular, appearing to be a wraparound, but with only the roof area extending fully past the northeast corner. The line of this roof section is carried into a segmentally curved section at the northeast end of the porch, with a full conical roof surmounting the whole. A decorative dentil course accents the entire porch's
