BUILDING-STRUCTURE INVENTORY FORM

ORGANIZATION (if any): Preservation Planning Workshop, Cornell University

30 West Third Street

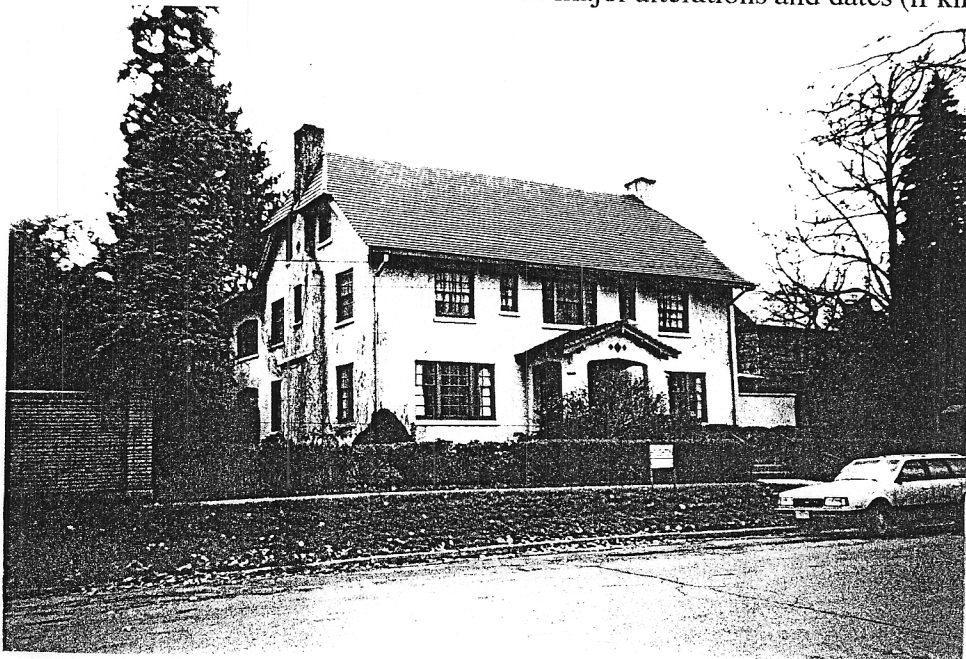
18. This two-and-a-half-story ~~end-gabled~~ Craftsman-style house has a wood frame covered with stucco. The ~~gables on the house~~ ^{are} jerkinhead gables. The Craftsman-style features of the house, which can be seen most clearly on the entry porch, include stuccoed wall surfaces, low-pitched, slightly flared roofs with exposed rafter ends, very low-pitched pointed arches, and decorative tiles.

The front facade, which faces north, is ^{portico} symmetrical around the center. The first story is notable for the one-story porch over the entry door. The porch has a low-pitched gable roof, stuccoed columns, and ~~the other features~~ decorative tiles described above. ~~The tiles centered over the main entry arch have designs in them.~~ On each side of the entrance ^{are three-part} windows with a ^{center} six-over-nine-light ^{sash} window in the center flanked by a four-over-six-light ^{sash} window on either side. ~~all double-hung sash~~ Centered above the entry porch, on the second story, is a similar ~~three-part~~ window. ~~On either side of this window is a two-over-four-light window, and beyond those, over the first-story windows, are eight-over-eight-light double-hung-sash windows.~~ ^{are also spaced across the front facade at the second story level.} Both ~~on the east and west facades~~ contain exterior chimneys, which ~~taper above the second story, and project out farther from the house with an overhanging drip moulding between the second and first stories.~~ A window is set ^{amid} in the chimney ~~itself~~ stacks at the second story level.

There is a one-story wall on the west side of house which blocks the view from the street ^{and} a two-story rear addition ^{that} exhibits ^{the same} many of the Craftsman-style details seen on the front facade, ^{is attached to rear facade} which had been ^{(south) porch}
