BUILDING-STRUCTURE INVENTORY FORM

- 1. BUILDING NAME(S):
- 2. COUNTY: Steuben TOWN/CITY: Corning VILLAGE:
- 3. STREET LOCATION: 247 Wall Street
- 4. OWNERSHIP: a. public [ ] b. private [x]
- 5. PRESENT OWNER: Robert McLean ADDRESS: 247 Wall Street
- 6. USE: Original: Single-family residence Present: Single-family residence
- 7. ACCESSIBILITY TO PUBLIC: Exterior visible from public road Yes[x] No [ ]  
Interior accessible: Yes [ ] No [x] Explain: Private Residence

CONTINUATION SHEET, Page 1  
247 Wall Street  
Corning, New York

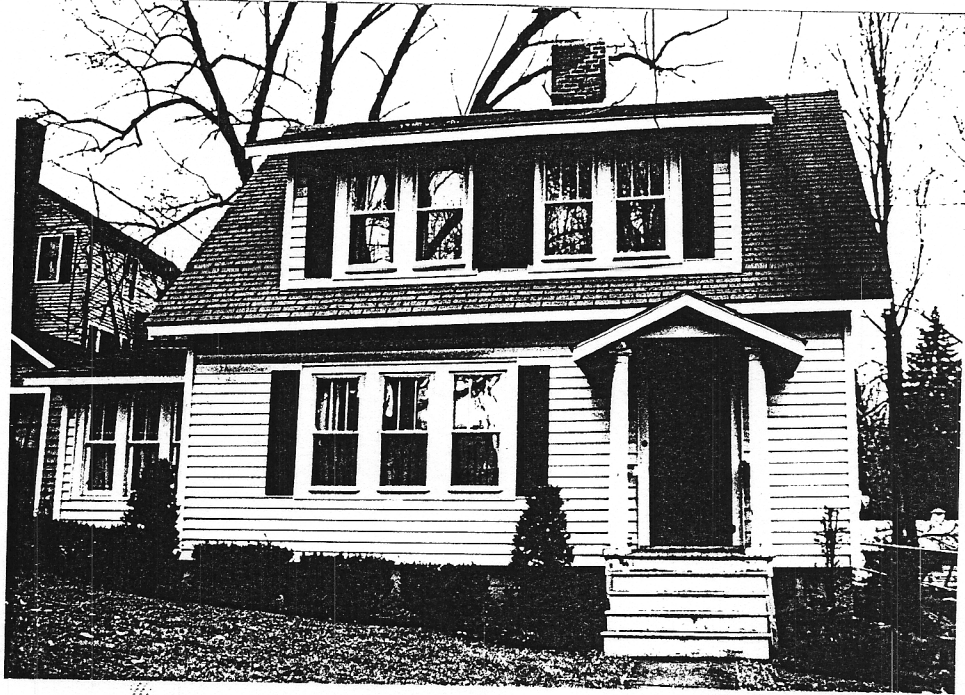
247 Wall St.

The configuration of elements on the first floor is asymmetrical. The main entrance is located to the north end of the front facade. Steps and a small wooden porch lead to this entrance. Two porch supports or columns support a small front-gable overhang. To the left of the front door is a ribbon window containing three windows in a double-hung three-over-one configuration. From the south facade of the home extends a small one-story bay. The windows located here are double-hung, in a two-over-one configuration.

East Facade
